LUFTFARTSDIREKTORATET
Avd. for Luftfartsinspeksjon
FORNÉBU-OSLO/Dep.
Tlf. : Oslo (02) 12 13 40
AFTN: ENFBYA
Tlgr. : CIVILAIR OSLO
Telex : 11032 Oslo

LUFTDYKTIGHETSPÅBUD
(LDP)

CESSNA
SAMMENDRAG
1946 - 1970

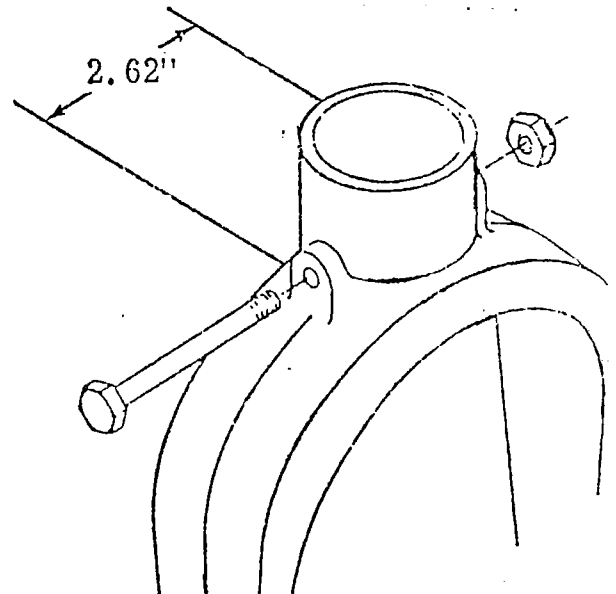
Figure 2. Early Type Nose Gear Fork.

Cessna 150, 172, 175 og 182 med den gamle type nesehjulsgaffel, vist i fig. 2. Fly som har nesehjulsgaffel med P/N 0442503-497, 0543043-497, 0543043-498, eller der det fremgår av en gyldig "Cessna Parts Catalogue" at flyet har en nyere nesehjulsgaffel, ref. fig. 1, berøres ikke av denne LDP.

På grunn av fare for brudd eller sprekker i nesehjulsgaffelen, skal følgende utføres:

1. Kontroller om det finnes sprekker i det utfreste området på nesehjulsgaffelen rundt bolten som fester gaffelen til resten av leggen.

Dersom sprekker oppdages, skal pkt. 2 utføres.

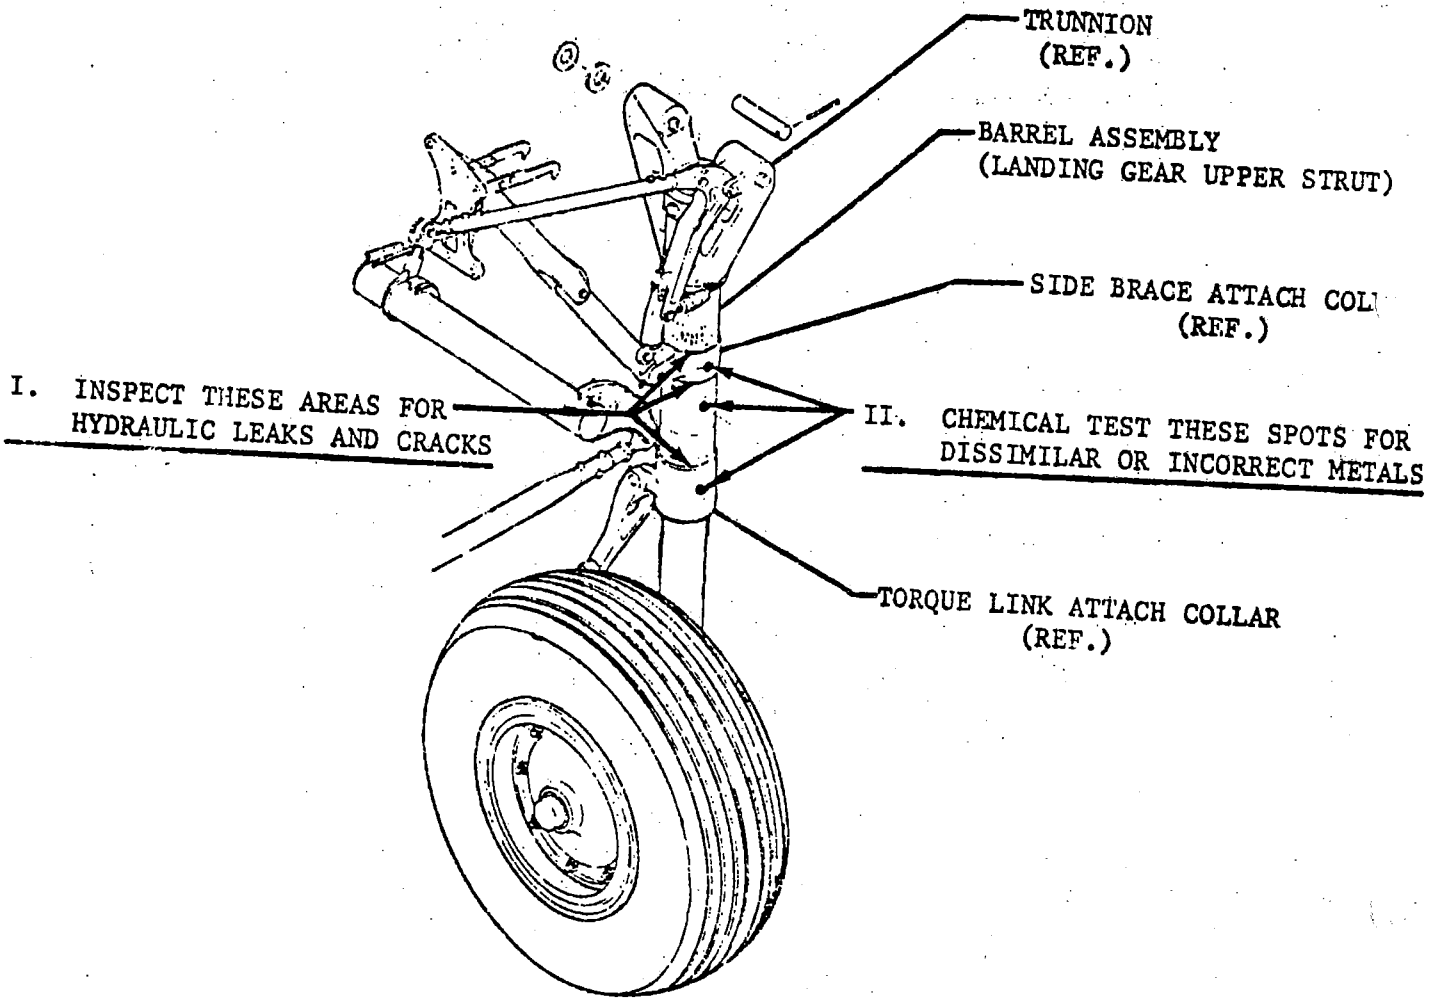
Fig. 1.

På enkelte fly er det oppdaget at hovedunderstellet er sammensatt av forskjellige eller feil materialer. Dette kan føre til sprekker eller brudd der feil materiale er brukt.

1. Kontroller visuelt om det finnes sprekker eller hydraulisk lekkasje på hovedunderstellet i de områder som er vist på fig. 1. Dersom feil oppdages, skal de omtalte sylindere skiftes før neste flyging.
2. Foreta en kjemisk test ifølge Cessna Service Letter ME 71-28 på de punkter som er vist i fig. 1. Deler av feil materiale skal byttes før neste flyging.

I. VISUAL LEAK CHECK --- BARREL ASSEMBLY OF MAIN LANDING GEAR UPPER STRUTS

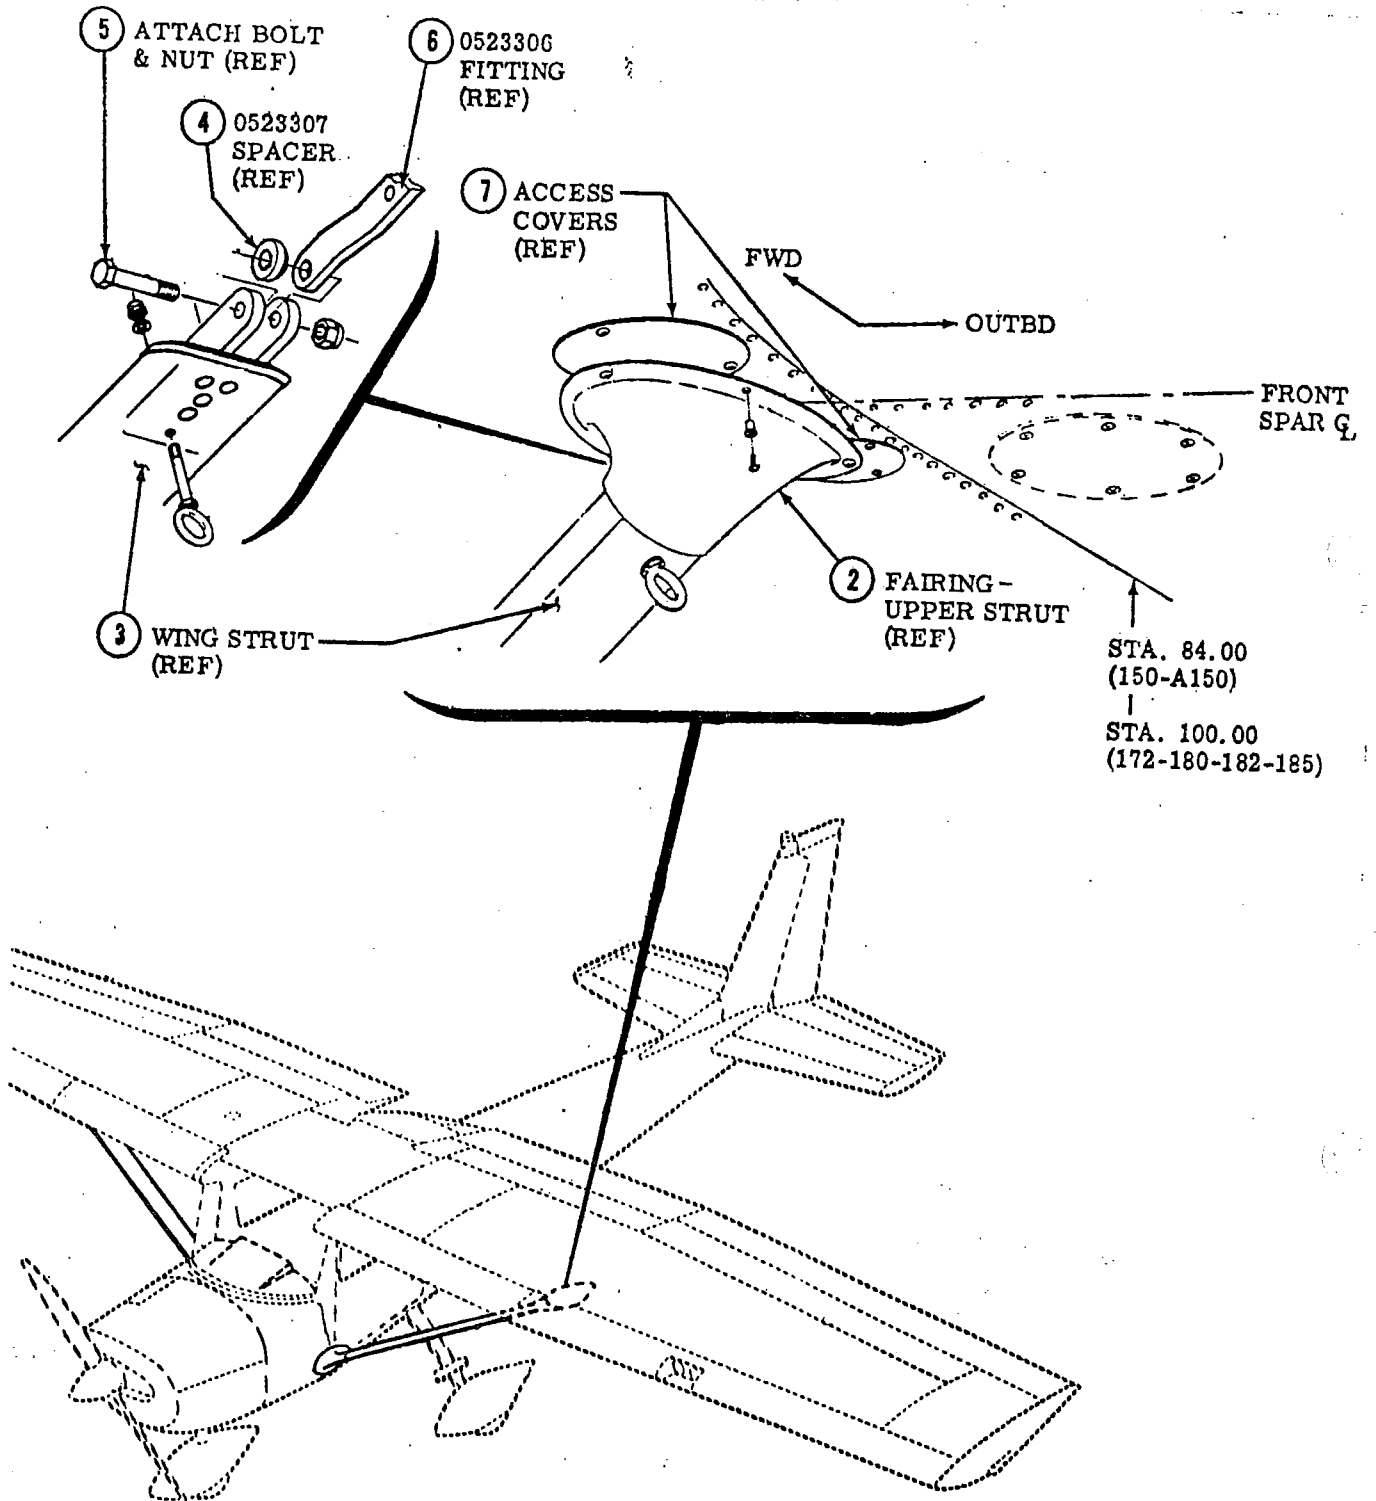
Fig. 1.

På grunn av feilaktig fabrikasjonsmetode for fremstilling av vingestendernes øvre innfestningsbeslag (P/N 0523306, se fig. 1) kan det forekomme sprekkdannelse i disse. Luftfartsverket påbyr derfor at beslagene skal skiftes ut med nye, som fås i Cessna Service Kit SK 150-45A.

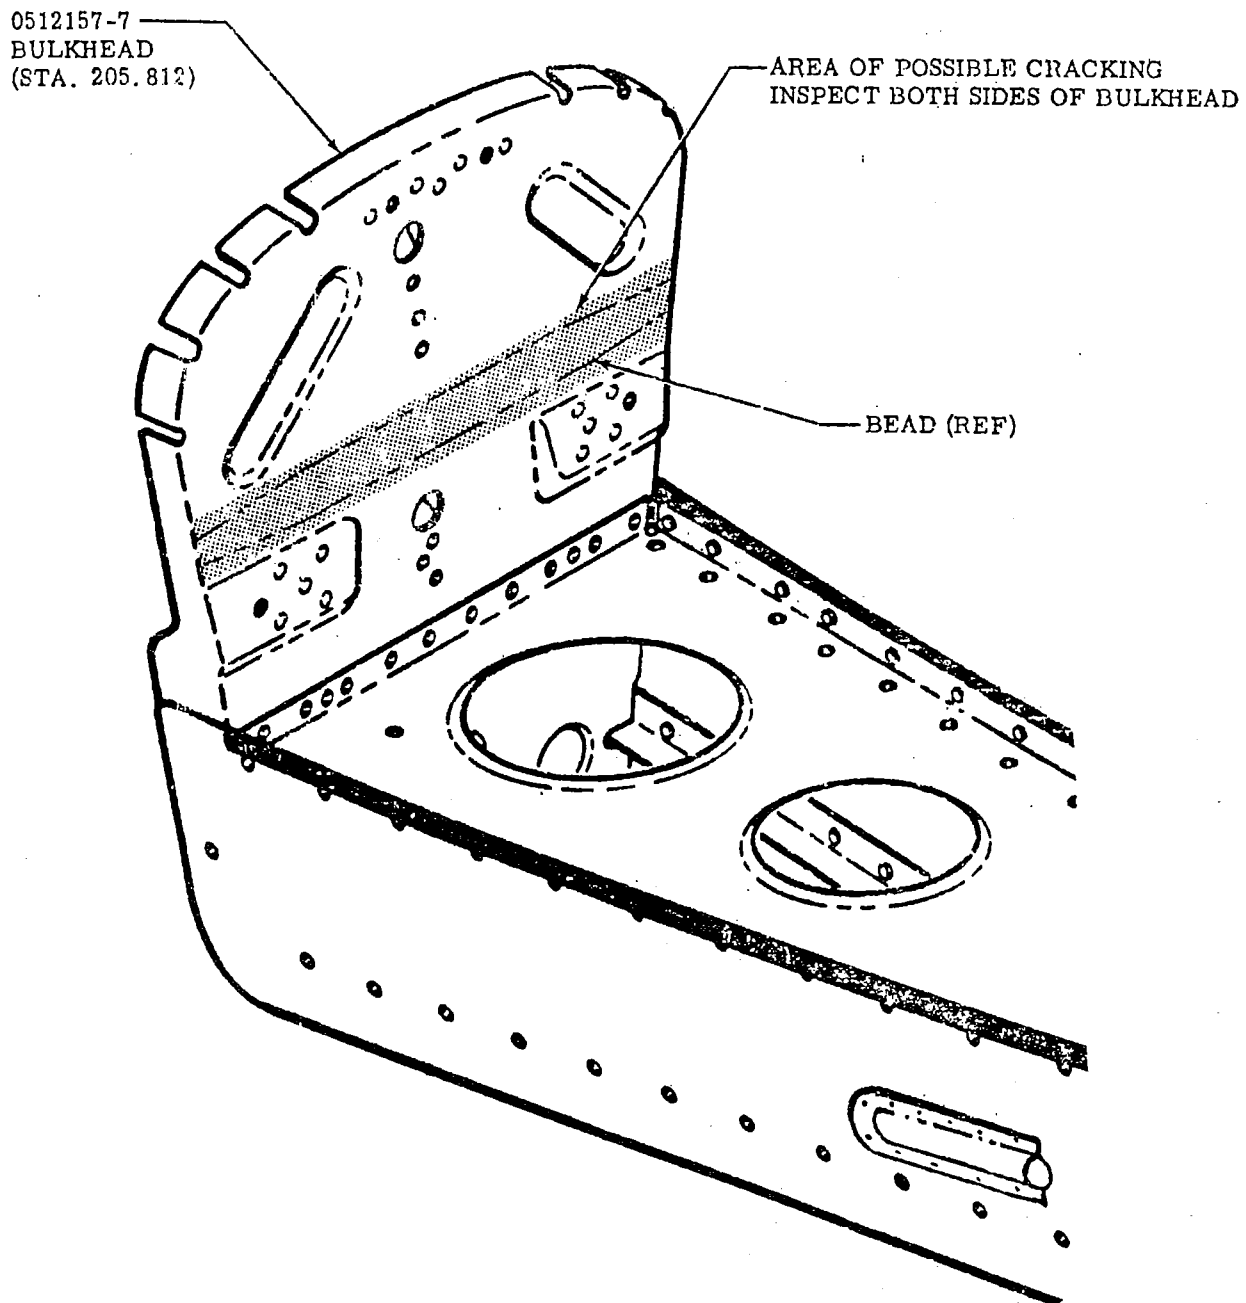
På grunn av feilfabrikasjon kan det forekomme sprekker i spant (P/N 0512157-7) ved stasjon 205.812 i fly med ovenstående serienr. Inspeksjon av spantet skal derfor utføres som beskrevet i Cessna Service Letter SE 73-37. Fig. 1 viser området hvor mulige sprekker er lokalisert.

Dersom en finner sprekker skal spantet repareres før videre flyging. Cessna Service Kit SK172-44 vil gi underlag for en slik reparasjon.

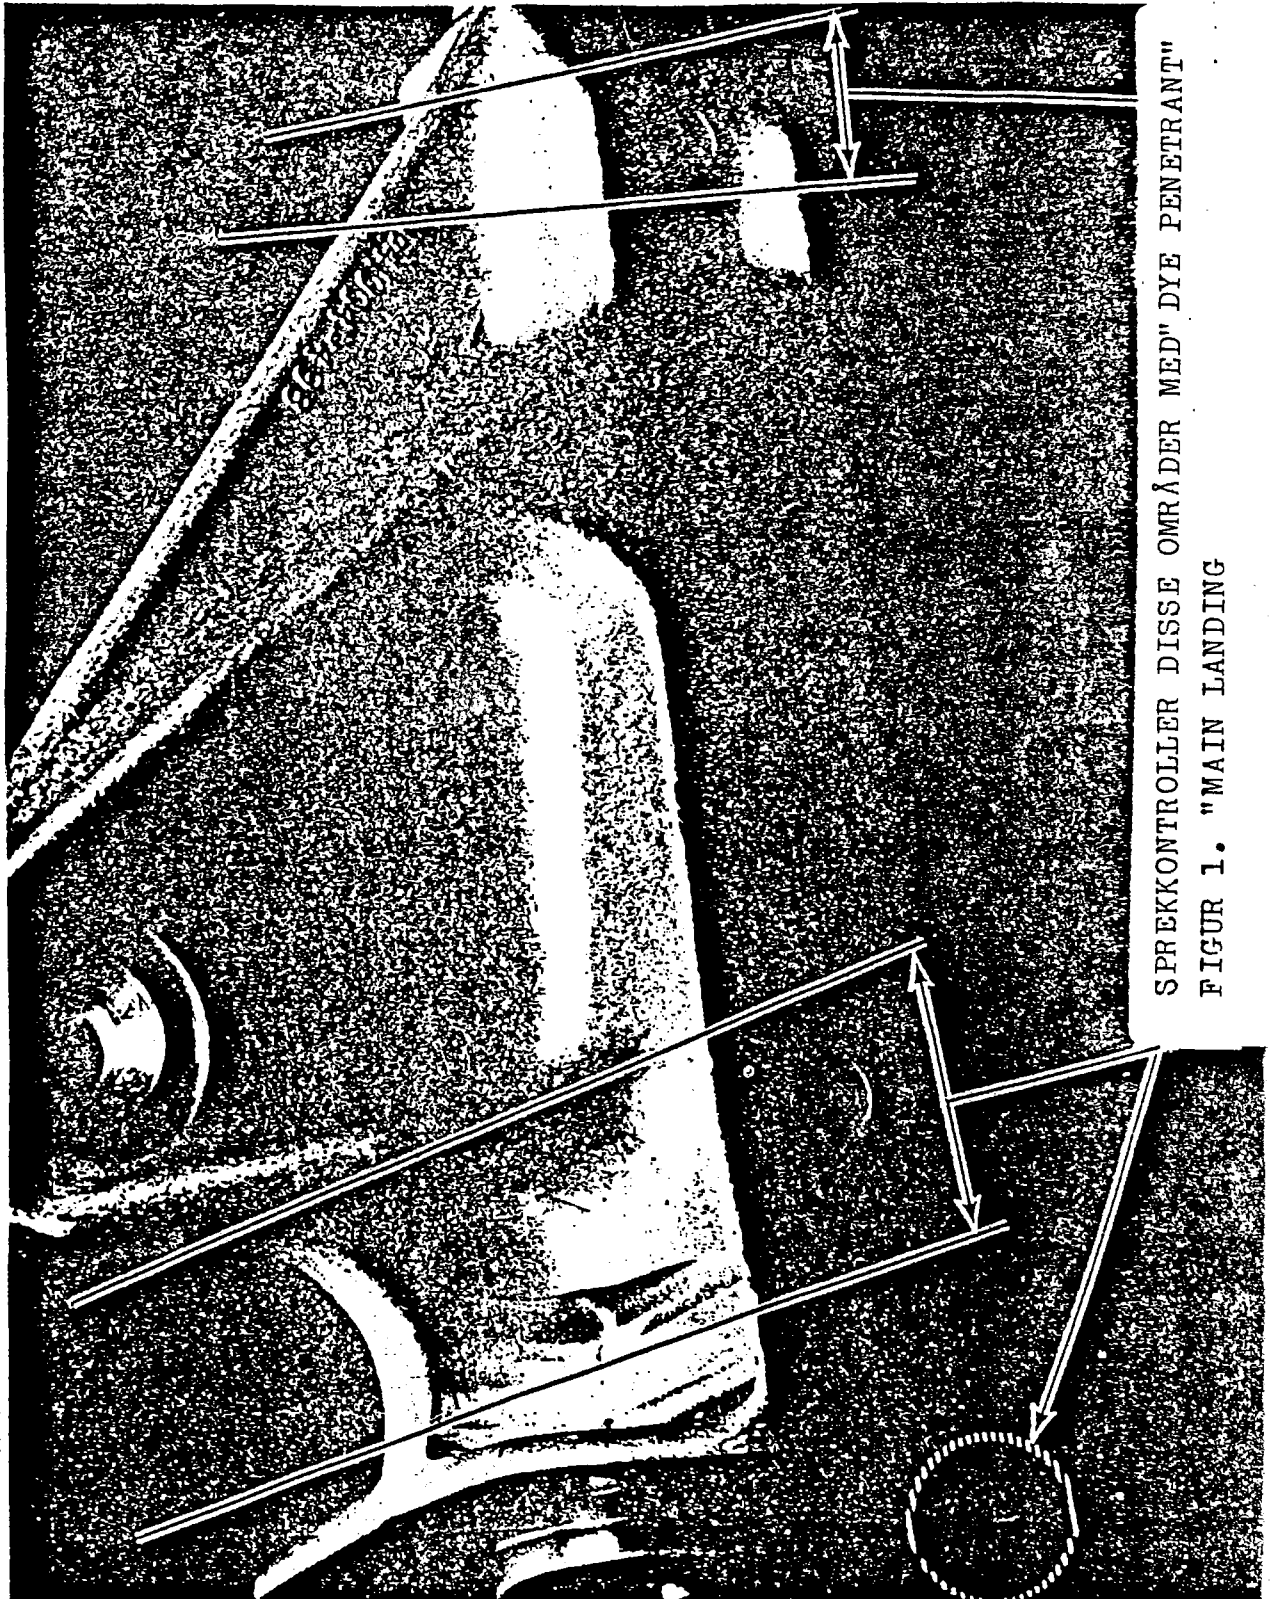
SPREKKONTROLLER DISSE OMRÅDER MED "DYE PENETRANT"
FIGUR 1. "MAIN LANDING"

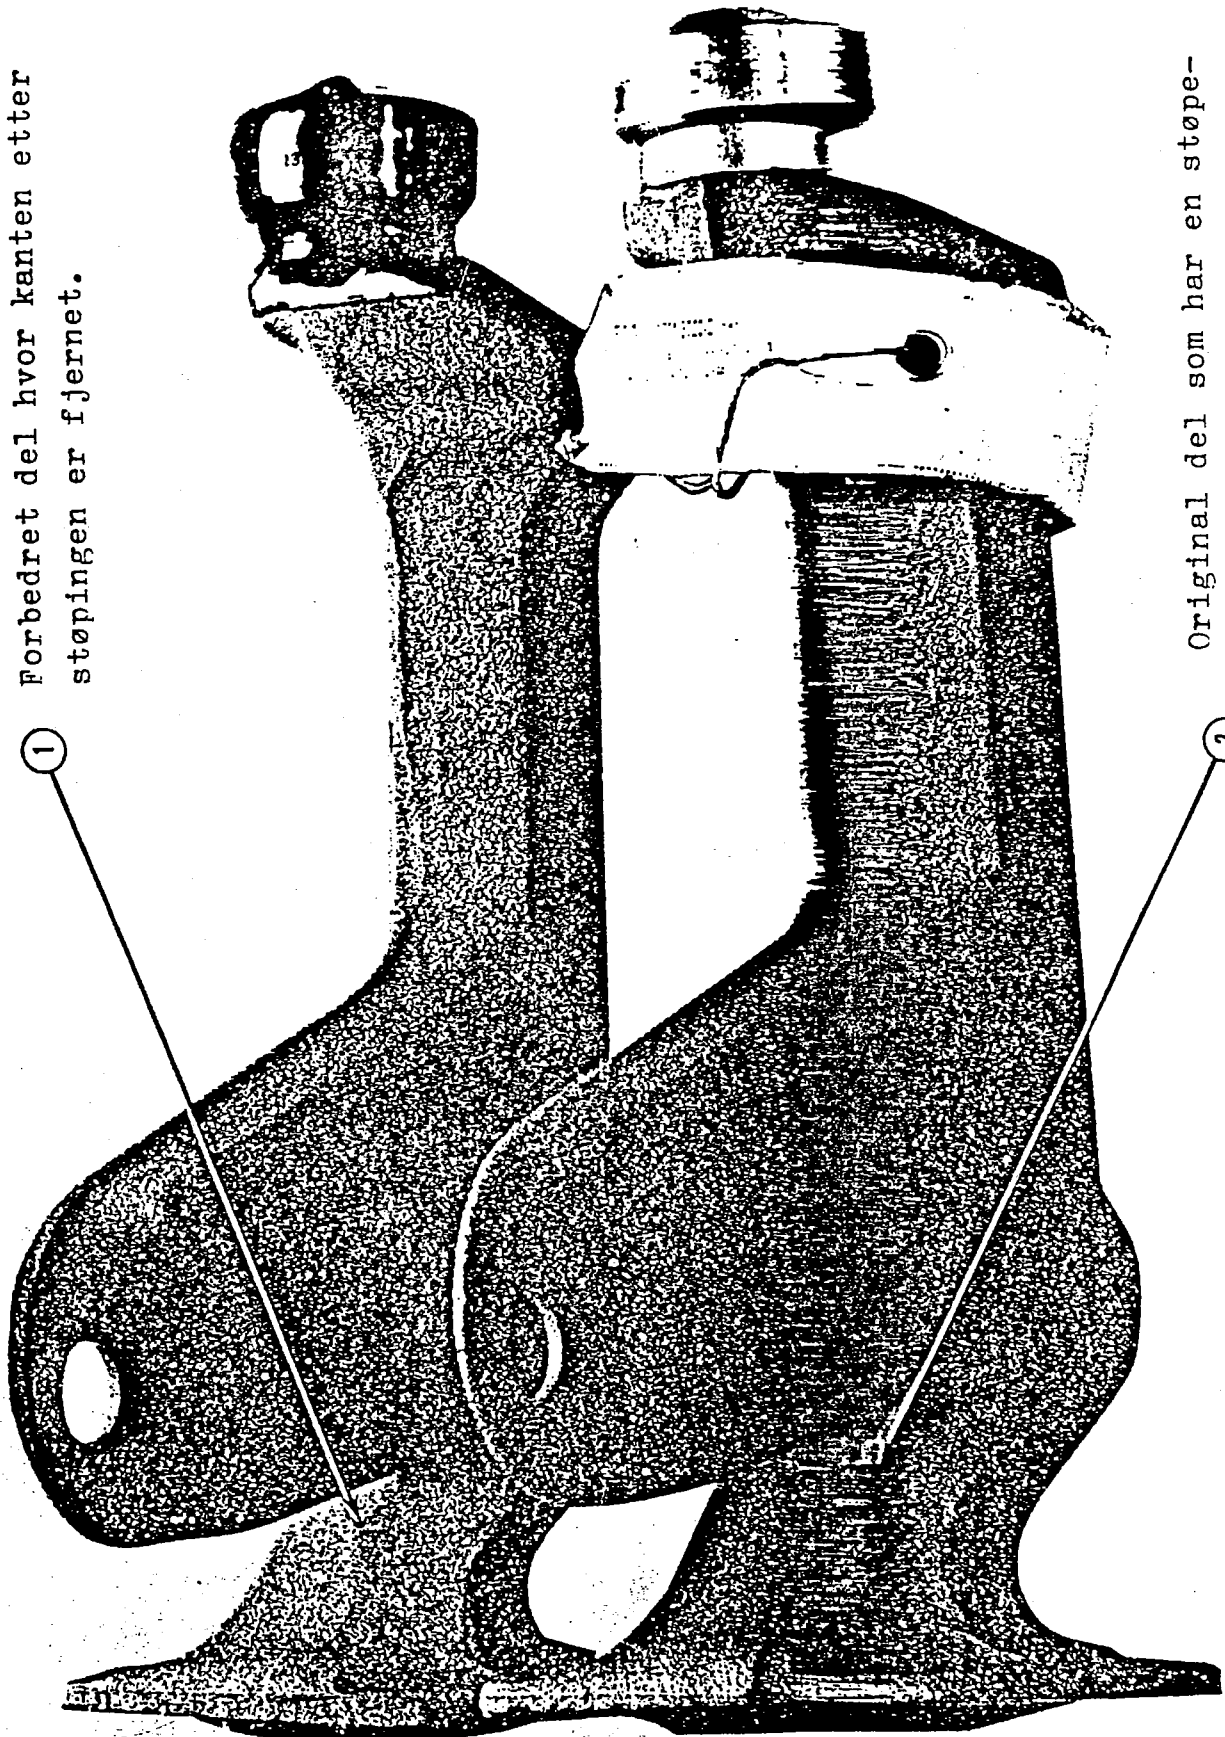
MAIN LANDING GEAR SADDLES

Forbedret del hvor kanten etter støpingen er fjernet.

Original del som har en støpe-
kant på ca. .10 tommer

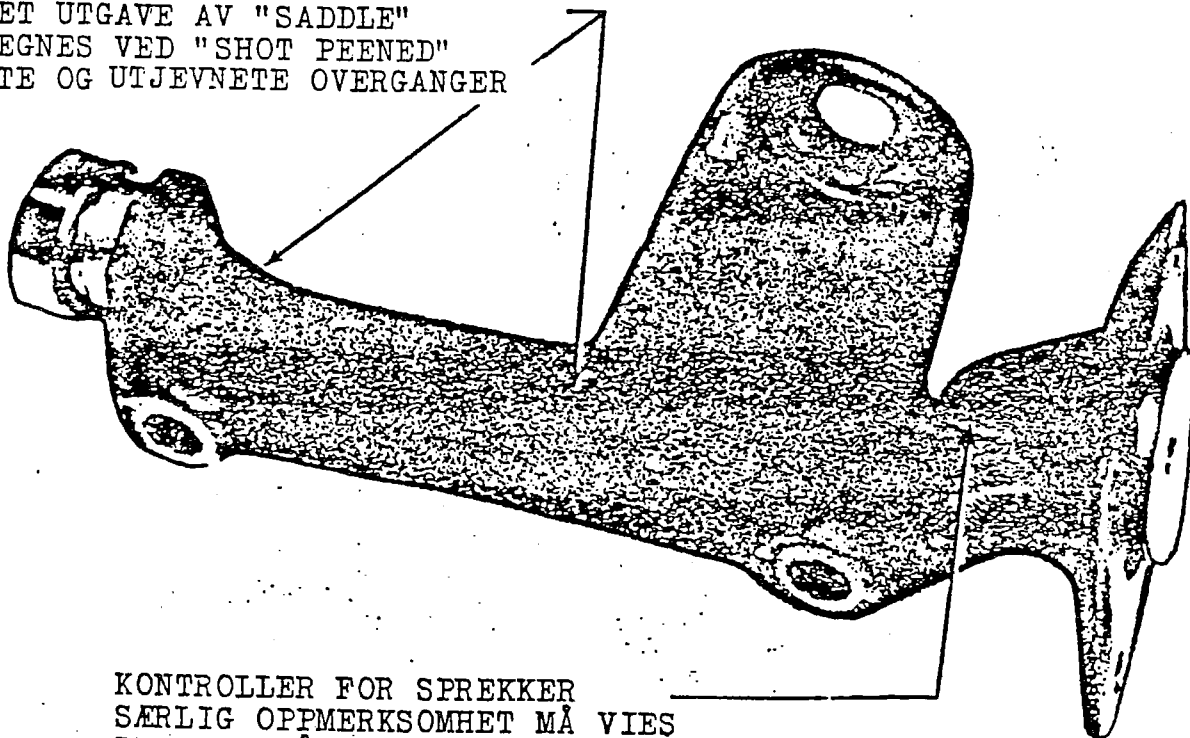
Figur 3

FORBEDRET UTGAVE AV "SADDLE"
KJENNETEGNES VED "SHOT PEENED"
OVERFLATE OG UTJEVNETE OVERGANGER

KONTROLLER FOR SPREKKER
SÆRLIG OPPMERKSOMHET MÅ VIES
DETTE OMRÅDET

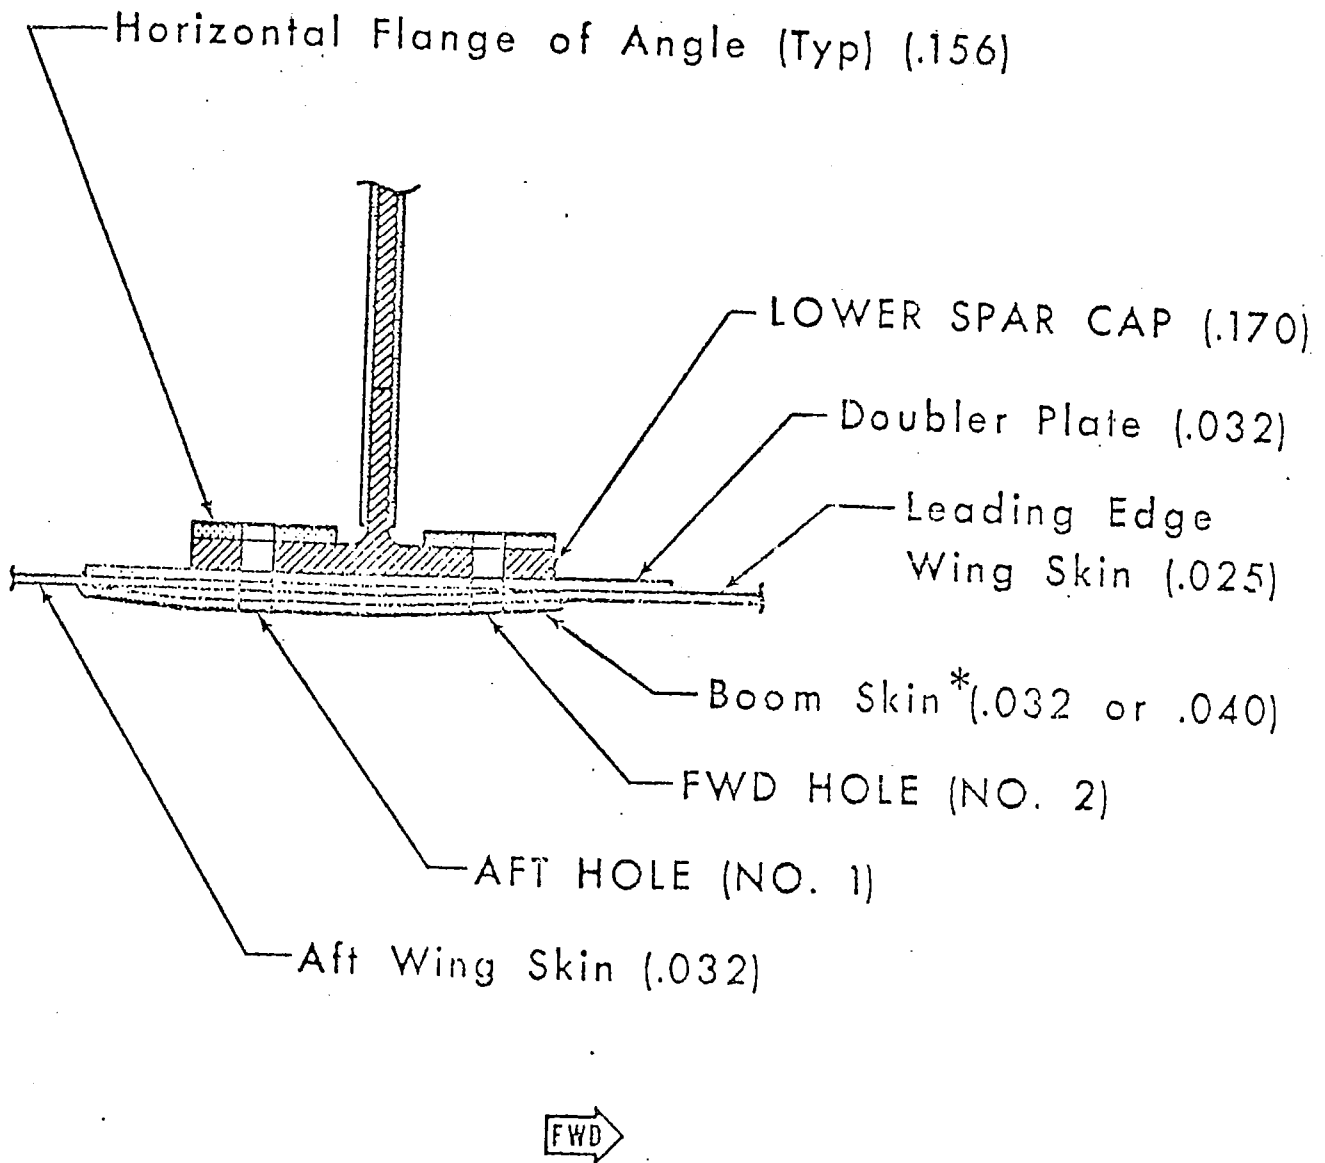
Fig. 2
AD 78-09-05

LOWER SPAR CAP AT FASTENERS
Wing Station 64.41

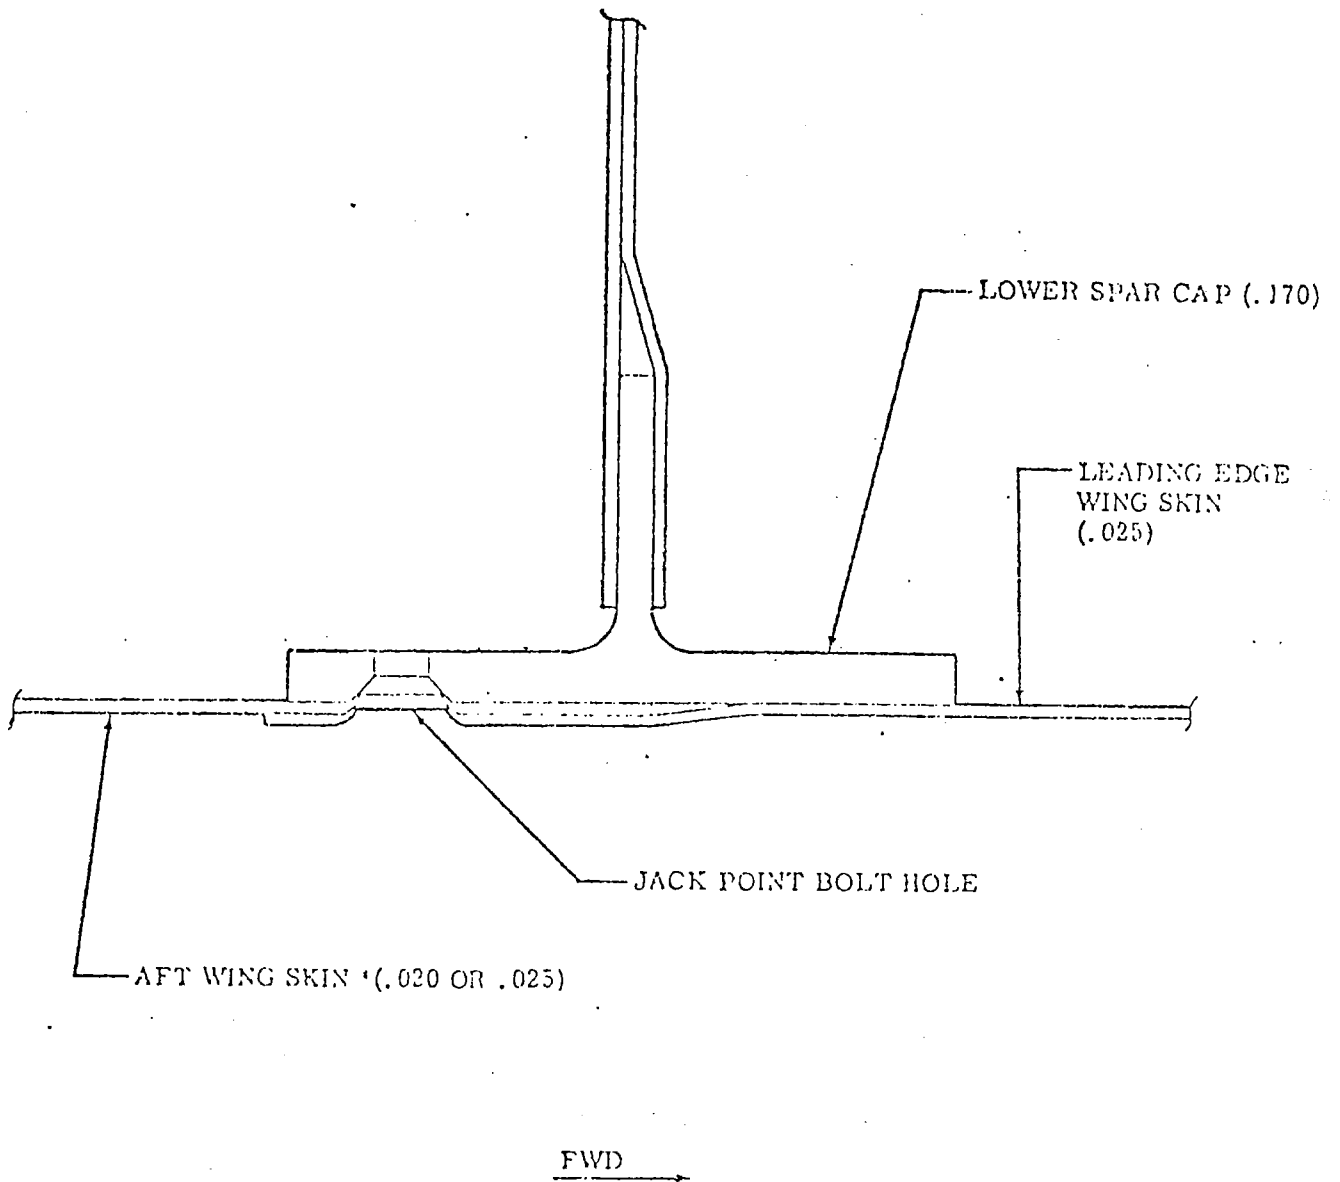
FIG. 4
AD-78-09-05

LOWER SPAR CAP AT JACK POINT

WING STATION 68.45

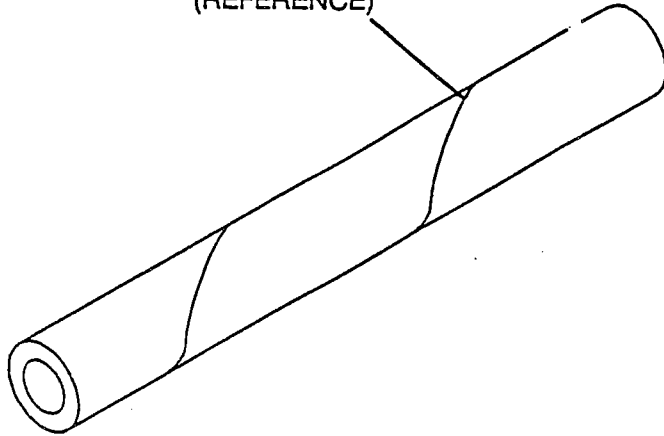
AD 97-01-13
Figure 1

OLD STYLE S51-10 HOSE
WITH REINFORCEMENT
WRAPPED IN ONLY ONE
(DIAGONAL) DIRECTION THE
LENGTH OF THE HOSE
(REMOVE AND REPLACE WITH
REPLACEMENT STYLE HOSE)

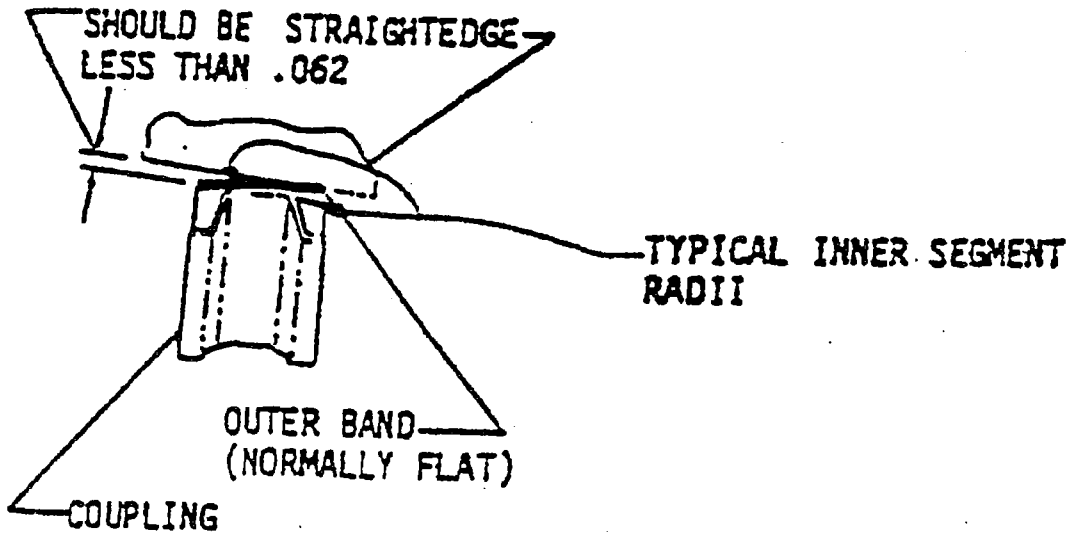
FIGURE 4 to the Appendix

than 0.062 inch. If deformation exceeds the 0.062- inch limit, replace the clamp(s) with new multi-segment clamp(s). (See Figure 3 of this Appendix). See Cessna maintenance manual(s) and revisions for correct installation procedures.

Multi-Segment "V" Band Clamp Outer Band Flatness Check

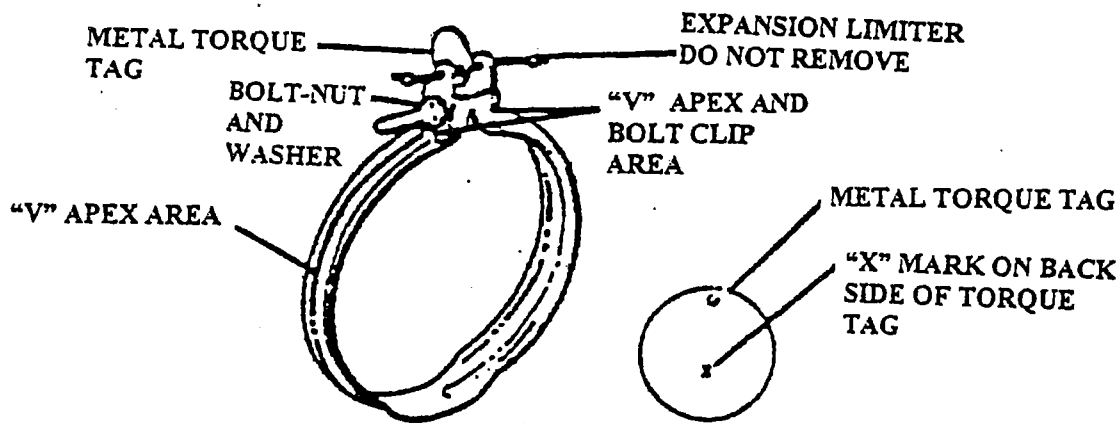
FIGURE 5 to the Appendix

(iv) Visually inspect the one-piece "V" band clamp (overboard exhaust to turbocharger) with a light and mirror, in the area of the clamp surfaces adjacent to the intersection of the "V" apex and bolt clips, and the entire length of the "V" apex of the clamp for signs of cracks or fractures. If cracks or fractures are visible, replace the clamp (see Figure 5 of this Appendix). See Cessna service manual(s) and revisions for correct installation procedures

One-Piece "V" Band Type Clamp
