## LUFTDYKTIGHETSPÅBUD (LDP)

MOONEY - 1

### 21/86 ETTERSYN OG REPARASJON AV DRIVSTOFFTANKER

### 92-044 KONTROLL AV SIDERORETS STATISKE BALANSE

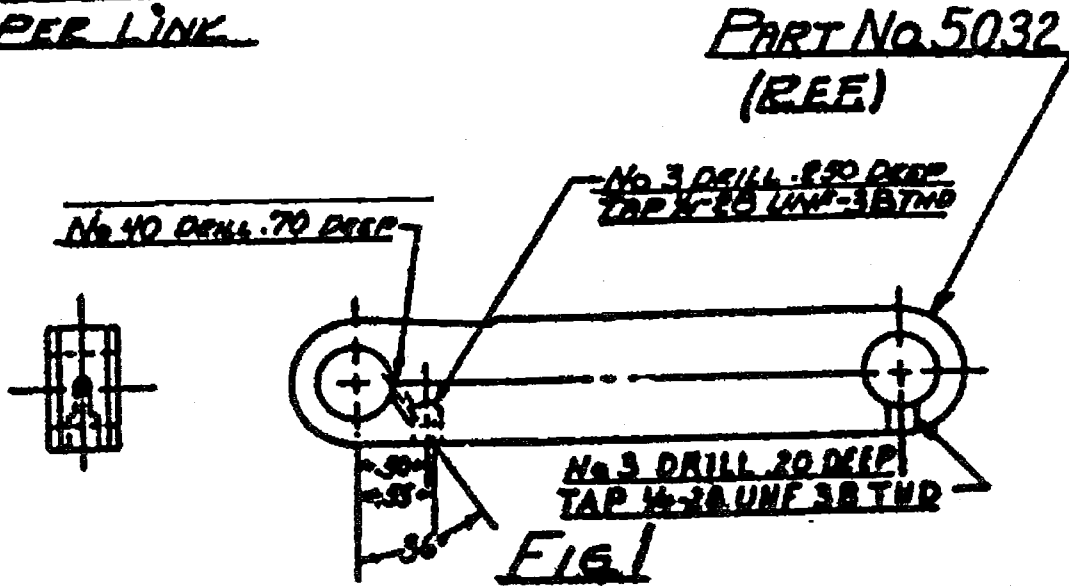
FIG.1

INSTALL MS15002-1  
GREASE FITTINGS 2 PLACES  
PER LINK

For M20 and M20A models the present retract links are to be modified by the addition of grease fittings as shown in Figures 1 and 2 attached. Follow procedures in Mooney M20/M20A Service and Maintenance Manual or other FAA approved procedure, for removal and replacement of links. Service Bulletins, Service Letters and Service Instructions referenced in this AD may be obtained from Mooney Aircraft, Louis Schreiner Field, Kerrville, Texas.
