LUFTFARTSDIREKTORATET
Ave. for Luftfartsinspeksjon
FORNEBU-OSLO/Dep.
Tlf.: Oslo 1021 12 13 14
Aftl.: ENFRYA
Tegn.: CI/ALAK OSLO
Telex: 11022 Oslo

LUFTDYKTIGHETSPÅBUD

CONTINENTAL

1946 - 1970

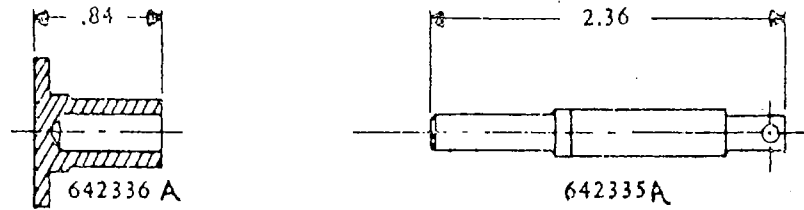
FIGURE 2

INTERMEDIATE DESIGN

Dersom skrue og stempel stemmer overens med dimmensioner i figur 2, "Intermediate Design", må delene skiftes ut med deler som stemmer overens med deler i figur 2, "Current Design". Disse fås i TMC Kit 642335A1. Skrue og stempel som stemmer overens med figur 1, "Original Design" kan fortsatt brukes. Hvor skrue og stempel stemmer overens med figur 1 og 3, skal ventilhuset merkes med en gul malingsflekk.

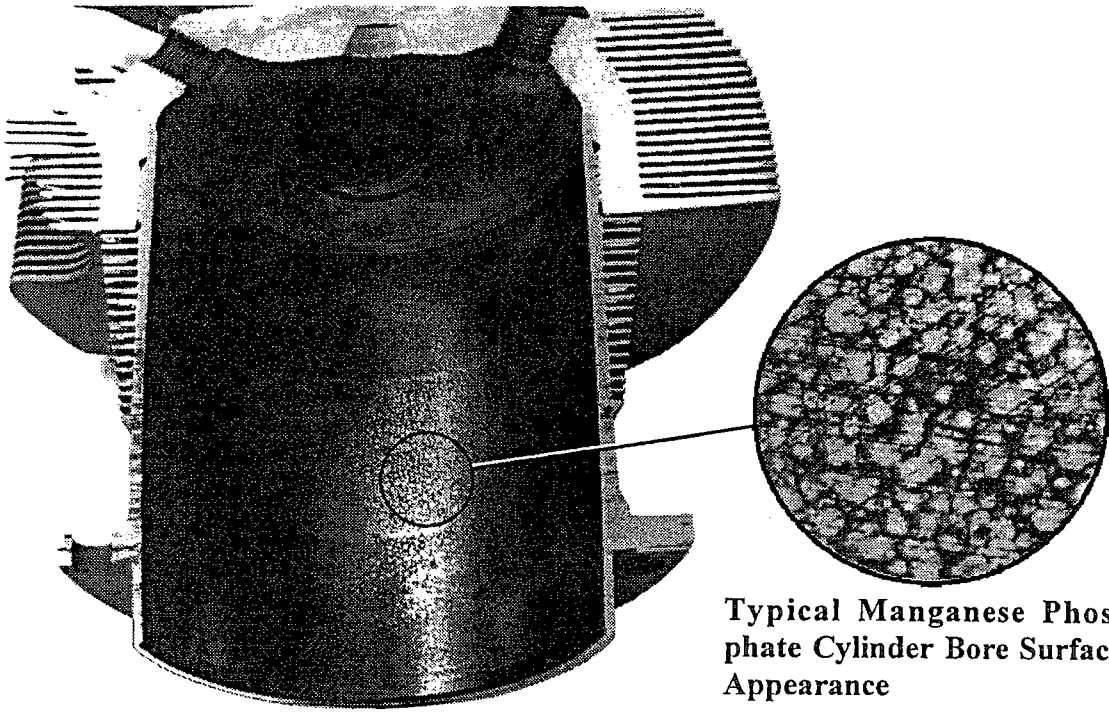
Figure 1.

Typical Manganese Phosphate Cylinder Bore Surface Appearance

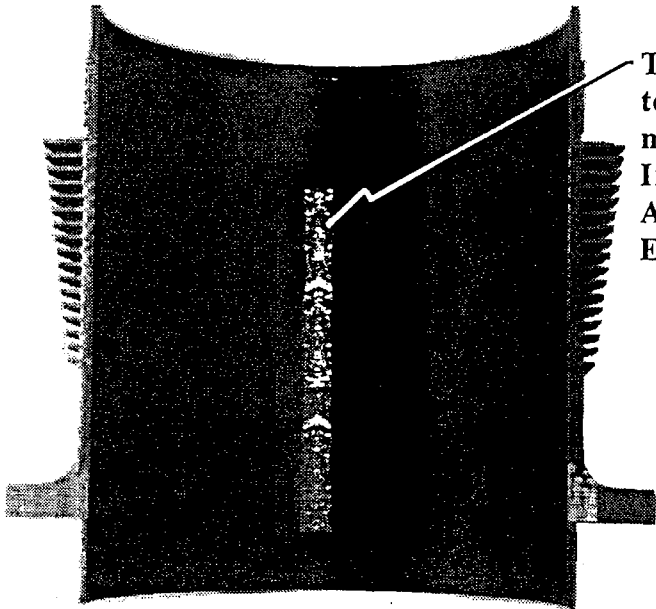
Figure 2.

This Type Of Narrow Wear Pattern Is Normal. Cylinder Removal Is Not Required Unless Indicated By Results Of Oil Analysis Or Oil Filter/Screen Examination.

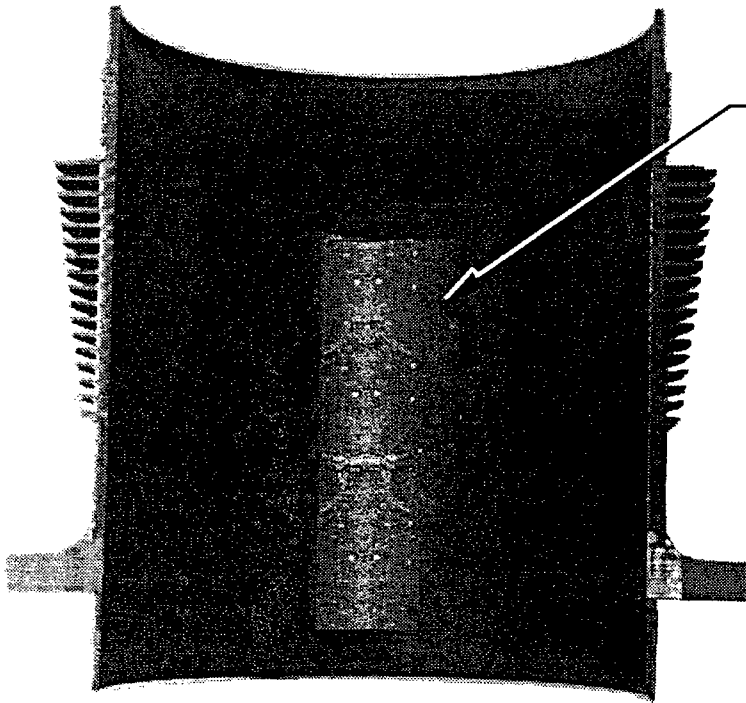
Figure 3.

Any Cylinder Bore That Exhibits This Type Of Wide Wear Pattern Must Be Removed For Inspection.

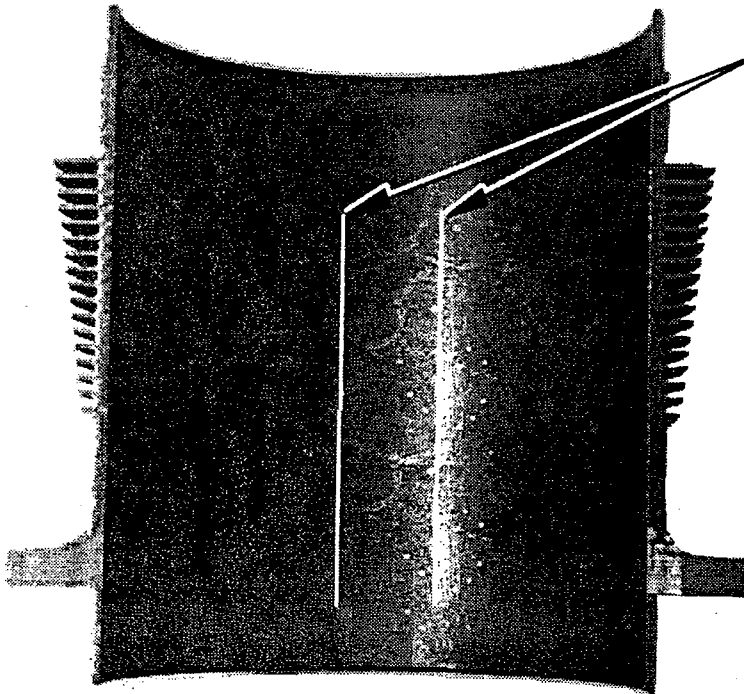
Figure 4.

Any Cylinder Bore That Exhibits These Distinct Vertical Wear Signatures At The 3 O'clock Position Or 9 O'clock Position Must Be Replaced.
