## LUFTDYKTIGHETSPÅBUD

AVCC  
LYCOMING  
SAMMENDRAG  
1946 - 1970

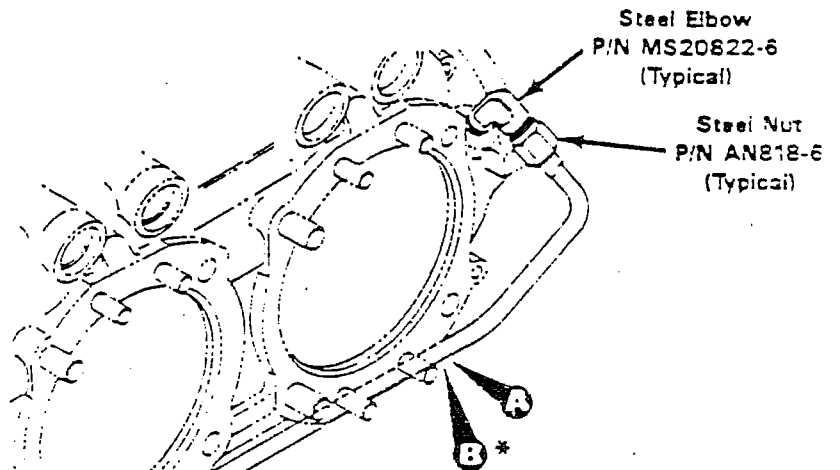
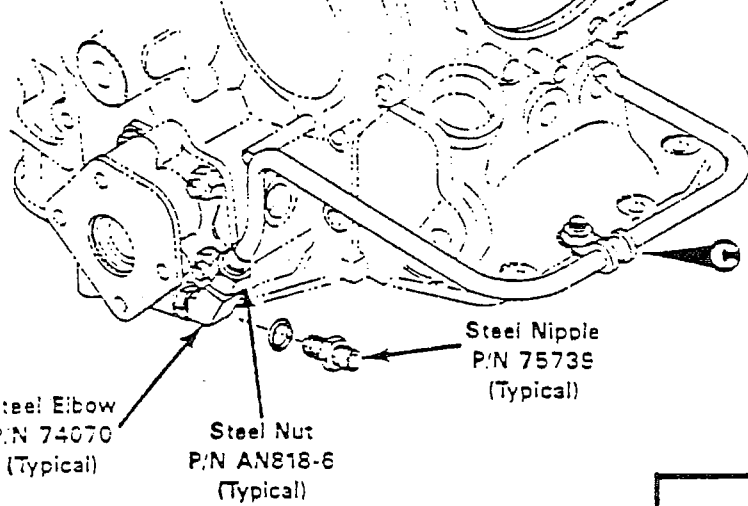
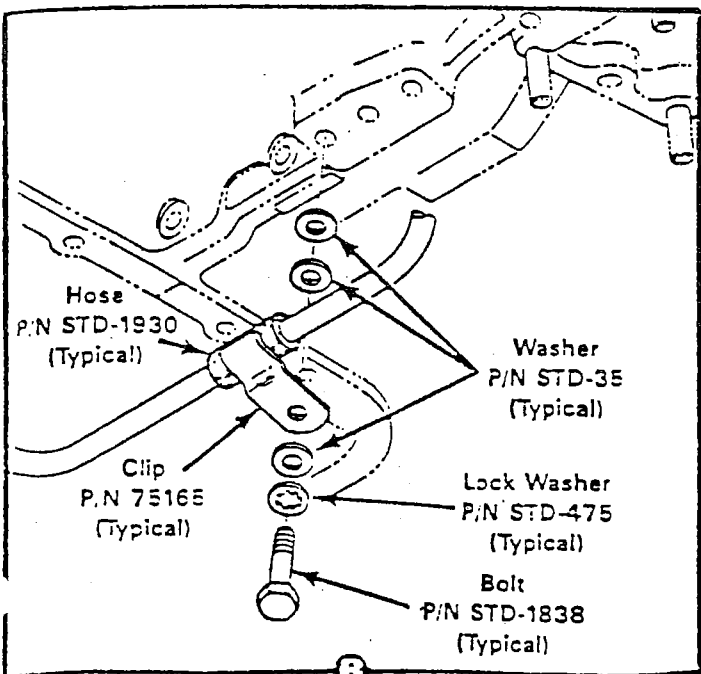
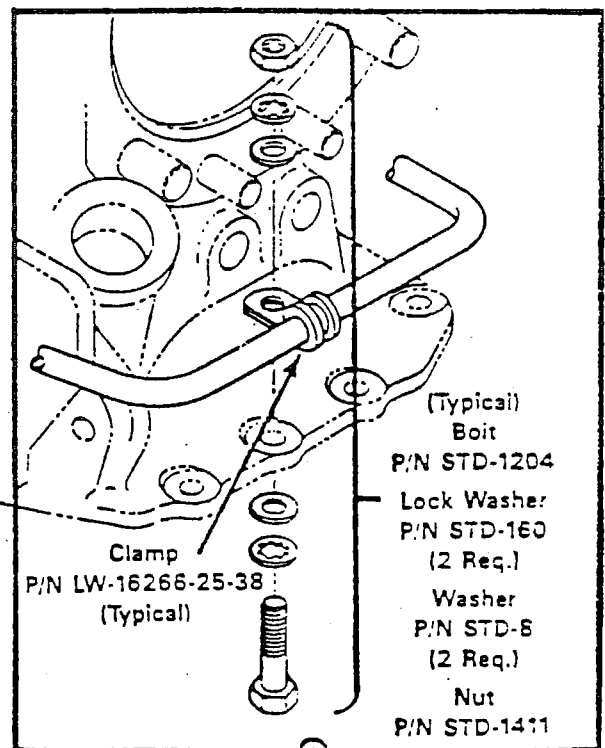
Figure 1. Propeller Governor Line Support

- 1.1 Kontroller det utvendige oljerøret for propellens "Governor" for gnissingsskader, sprekker og oljelekkasje langs hele rørets lengde samt tilkoblingene i begge ender. Verifiser at de to forede klamre eller klips er på plass som vist i figur 1 i Bilag 1 til denne LDP.

- 2.1 Fjern enhver oljerørsenhet som har integrerte festemuttre i aluminium, og installer en oljerørsenhet med tilsvarende deler i rustfritt stål. Skift ut alle aluminiumsfester på veivkassen og propellregulatoren med nye av stål, som vist på figur 1 i Bilag 1 til denne LDP.

Textron Lycoming has approved the usage of the Piper Aircraft Corp. air conditioning bracket as a support of the propeller governor line. The split Hose P/N STD-1930 must still be used along with the bracket and hardware supplied by the airframe manufacturer. It is essential that the attaching bracket is properly installed so that it firmly supports the split hose covered governor line to the crankcase.

\* Most older standard cylinder flange engines differ at this crankcase attaching point of the propeller governor line as opposed to the wide cylinder flange attachment shown in this illustration. Standard cylinder flange engines use an Adel clamp which attaches to the bottom crankcase perimeter bolt directly aft of the generator bracket. Fittings for standard cylinder flange line may be -5 (5/16") instead of -6 (3/8"). Also, some earlier model propeller governor drives used 1/4" NPT fittings in the prop. governor adapter. If any of these fittings are found, replace with equivalent AN or MS steel fittings.
