LUFTDYKTIGHETSPÅBUD

RANGER

**2003-044 KONTROLL/MODIFIKASJON AV STEMPEL VED OVERHALING ELLER VED
INSTALLASJON AV NYE STEMPEL**

2003-045 "CARBURETOR HOTSPOT HEATER ASSEMBLY"

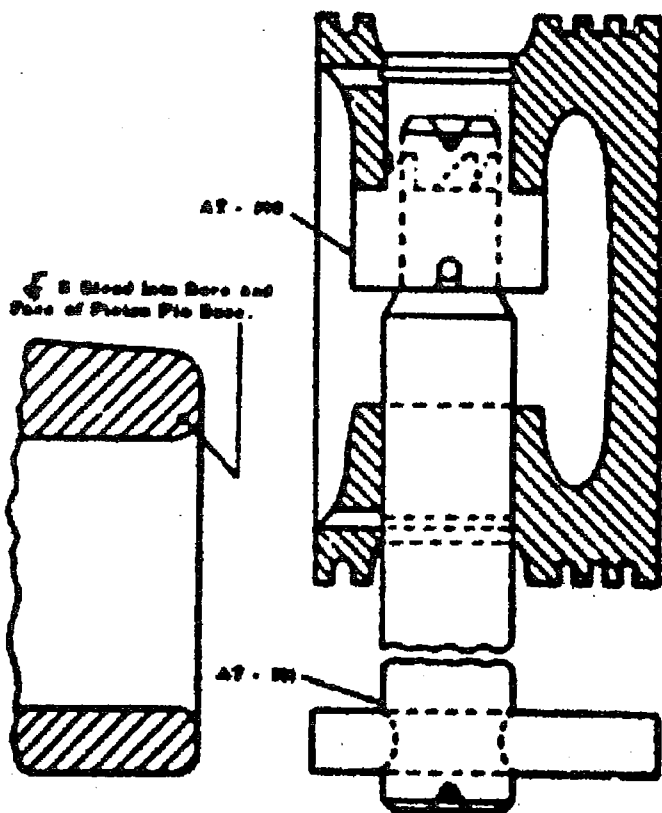
FIGURE 1

- (a) Inspect pistons by the fluorescent penetrant inspection method, or an equivalent, for cracks especially in areas around the piston pin boss and on the reinforcing web inside the piston. If cracks are found in these locations, the piston should be discarded.
- (b) Inspect pistons to ascertain if a 3/32-inch radius has been added at the inner ends of the ID of the piston pin bosses. Pistons which do not incorporate this radius should be modified as shown in **Figure 1** in order to relieve stress concentrations. Pistons with cracks in this location which cannot be removed by the following modification should be discarded also.

After thoroughly cleaning the piston, place it head down on the bench; insert cutter No. AT-390, or an equivalent, between the piston pin bosses, facing in the direction of the boss to be cut. Insert handle No. AT-391, or an equivalent, through the opposite boss and engage with cutter. Cut radius by rotating cutter in a clockwise direction until the outer end of the 3/32-inch radius blends into the surface at the end of the piston pin boss.

Repeat this procedure for the opposite piston pin boss.
