LUFTFARTSVERKET
Novedadministrasjonen
Avd. for luftfartsinspeksjon
Postboks 18, 1330 Oslo lufthavn
Telefon: Oslo (02) 59 33 40
AFTN : ENFBYE
Tlgr. : CIVILAIR OSLO
Telex : 77011 Idal n

LUFTDYKTIGHETSPÅBUD (LDP)

ROBINSON - 1

1056/90 MODIFIKASJON AV LUFTFILTERHUS

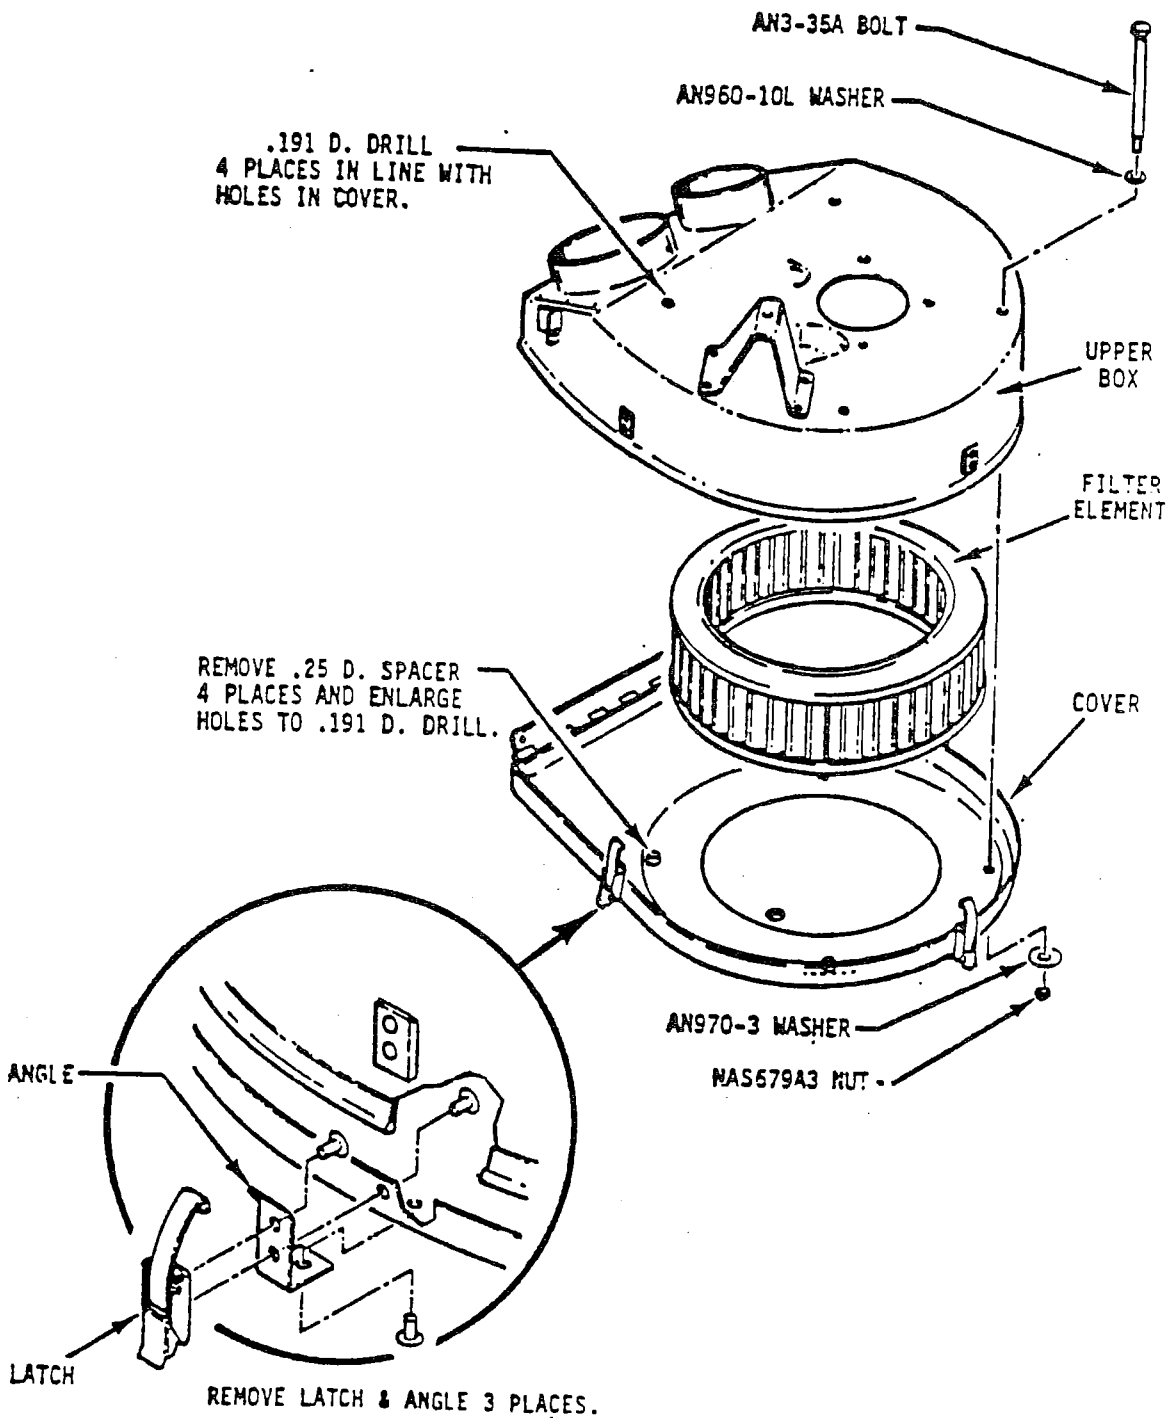
VEDLEGG 1 TIL LDP 056/90

For å hindre at låseklemmene løsner under flyging skal følgende tiltak utføres:

1. Fjern de tre festeklemmene, og erstatt disse med fire bolter i samsvar med følgende fremgangsmåte, ref. vedlegg 1 til denne LDP:
 - 1.1 Åpne filterhuset og fjern luftfilterelementet.
 - 1.2 Demonter filterhuset fra helikopteret.
 - 1.3 Bor ut de fire naglene i dekselet som holder de 0.25" (6.35 mm) tykke avstandsstykkene og øk hullenes diameter til 0.191" (4.85 mm). Avstandsstykkene kasseres.
 - 1.4 Lukk igjen dekselet, og ved å benytte hullene i dekselet som styring bores fire tilsvarende hull gjennom det øvre huset på linje med hullene i dekselet.
 - 1.5 Åpne luftfilterhuset og bor ut naglene som fester klemmene til huset. Kasser klemmene og rengjør filterboksen.
 - 1.6 Monter luftfilterhuset på helikopteret.
 - 1.7 Installer filterelementet og sikre dekselet ved å benytte fire AN3-35A bolter, AN960-10L skiver, AN-970-3 skiver og NAS679A3 mutre.

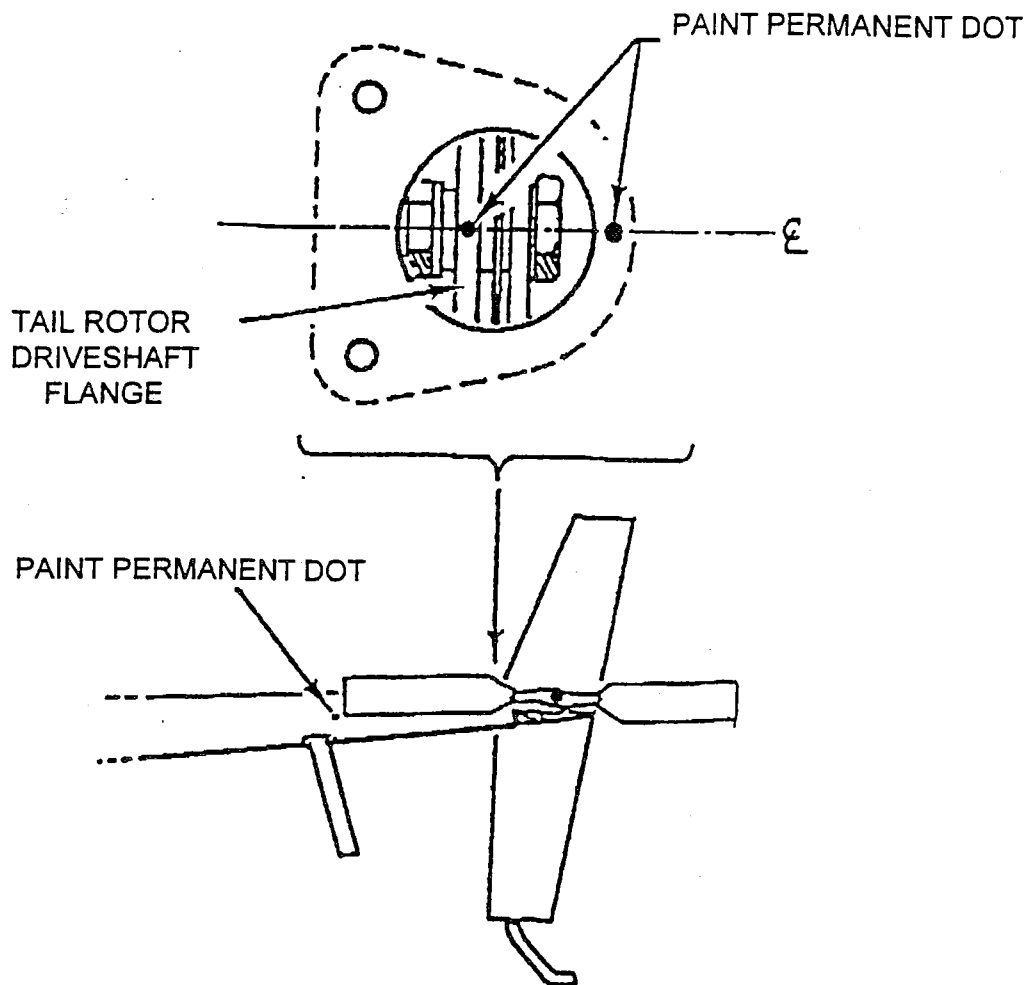
Figure 4

To prevent slippage of the T/R drive, loss of directional control, and subsequent loss of control of the helicopter, accomplish the following:

(a) Before further flight, install alignment dots as follows: Remove the transparent inspection cover on the tail cone and rotate the T/R blades so that one blade leading edge is aligned with the tail cone centerline. Mark a dot on the tail cone skin aligned with the tip of the blade leading edge. With the same alignment, mark a dot on the centerline of the tail cone skin at the edge of the inspection hole, and mark a corresponding dot on the drive shaft flange (see figure 4).

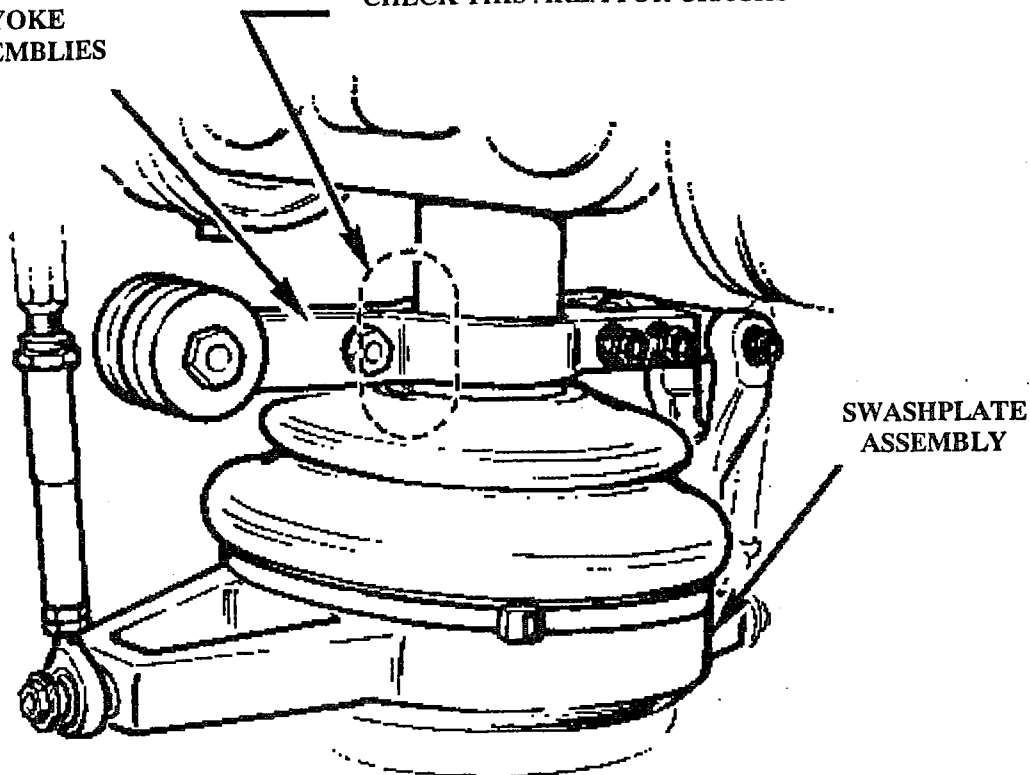
Figure A

CHECK THIS AREA FOR CRACKS

(e) Determining that the installed yokes, P/N A203-5, are not in the lots affected by this AD, or replacing yokes, P/N A203-5, with yokes, P/N A203-7, is terminating action for the requirements of this AD.

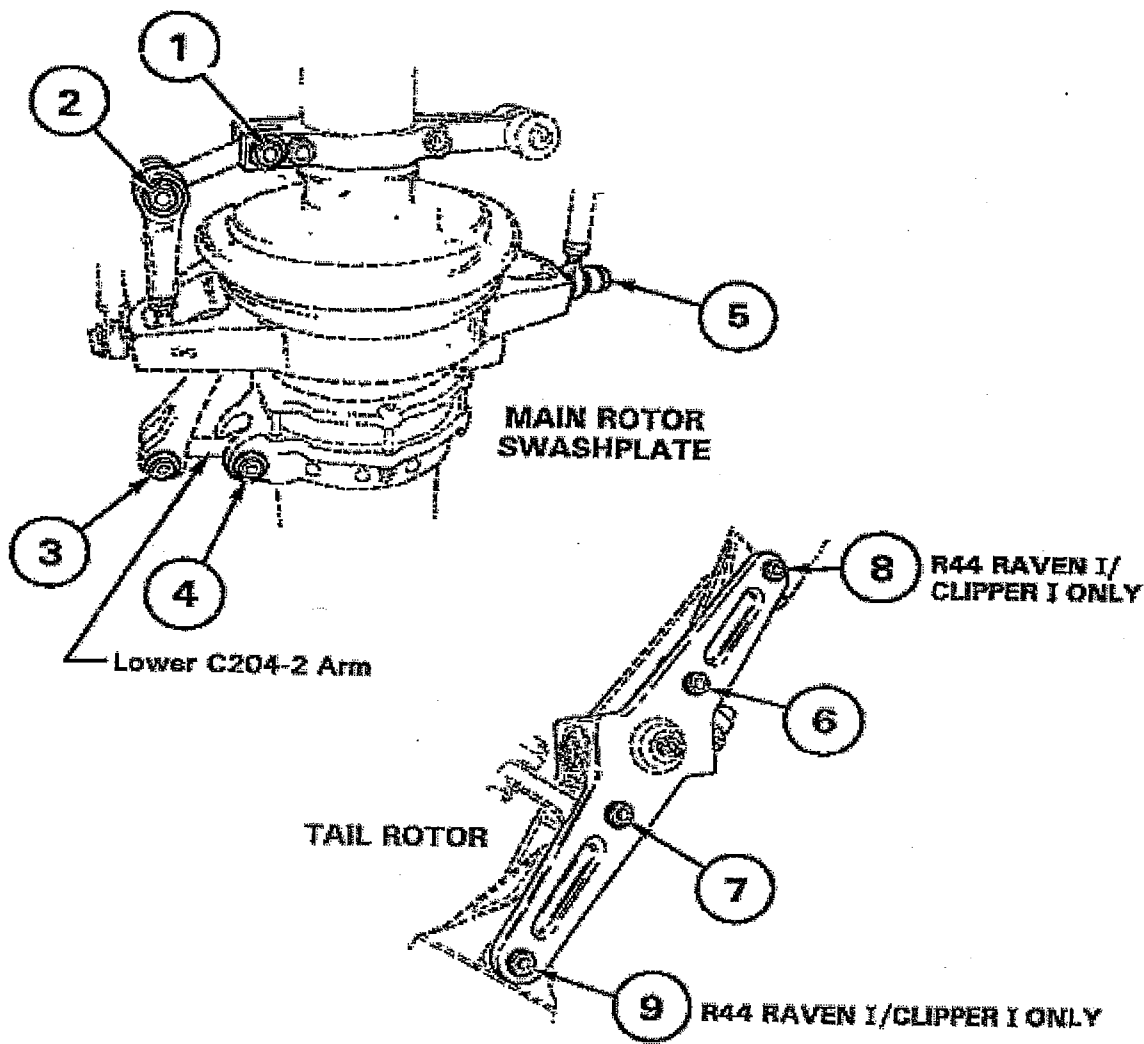
Figure 1

Suspect NAS6605-31 Bolts
 9 Place on R44
 7 Places on R44 II

(3) If residue or rotation of the bolt is found, before further flight, replace each unairworthy bolt with an airworthy bolt that does not have a vendor identification marking of 01DO.

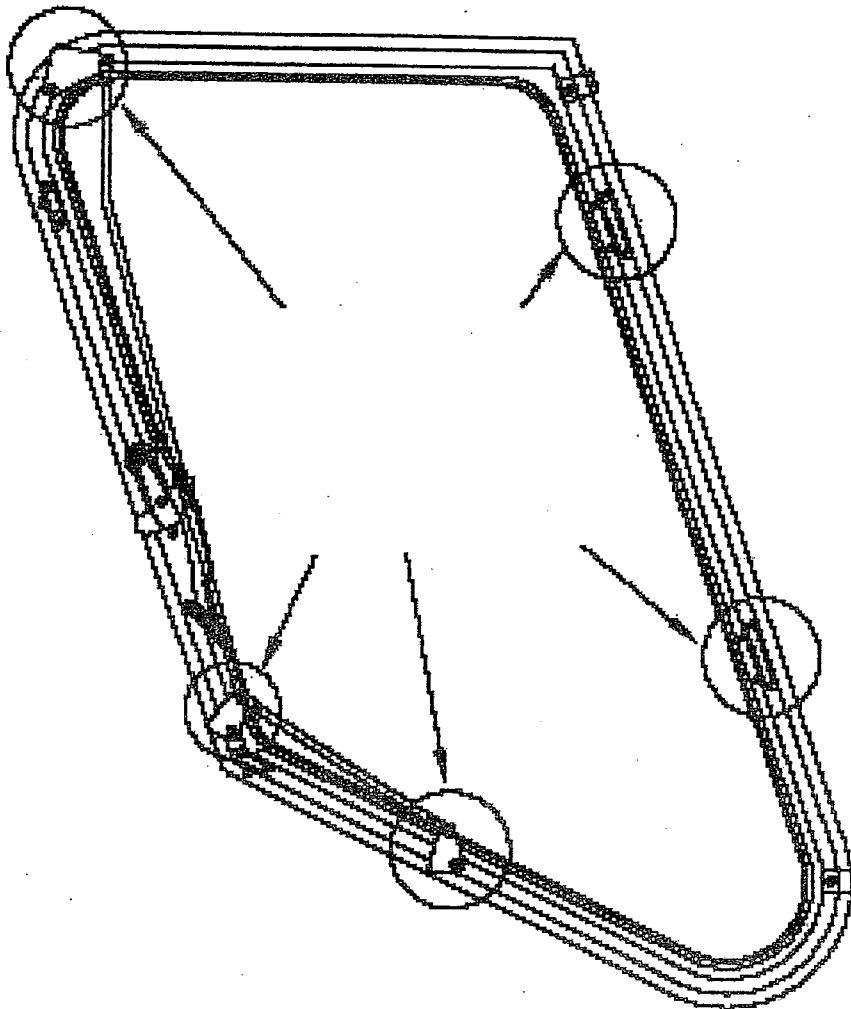
(1) Visually inspect each pilot and copilot door assembly integral frame for a crack in the locations depicted in Figure 1 of this AD. If a crack is found, before further flight, replace the cracked door assembly, part number (P/N) R-22-101-51 or P/N R-22-101-53 (left-hand door assembly), or P/N R-22-101-52 or P/N R-22-101-54 (right-hand door assembly), with an airworthy door assembly. If you use door assembly, P/N R-22-101-51 or P/N R-22-101-53 (left-hand door assembly), or P/N R-22-101-52 or P/N R-22-101-54 (right-hand door assembly) as the replacement, then install it in accordance with Tech-Tool Plastics, Inc. Installation Instructions TTP-1R, Revision A, dated November 21, 1997, and with the sections titled "Door Weather Seal Installation" and "Cotter Pin Installation" in Tech-Tool Plastics, Inc. Service Bulletin No. TTP2005-01, Revision A, dated February 1, 2005 (SB).
