LUFTHAVSVERKET  
LUFTHAVSVEIEN 11, 1330 OSLO LUFTHAVN  
LUFTDYKTIGHETSPÅBUD  
(LDP)

Seilfly  
Rolladen Schneider-lb  
Erstatter Rolladen-  
Schneider-la

58/78 KONTROLL AV RUST PÅ CG-SLEPEKROKENS UTLØSERKABEL

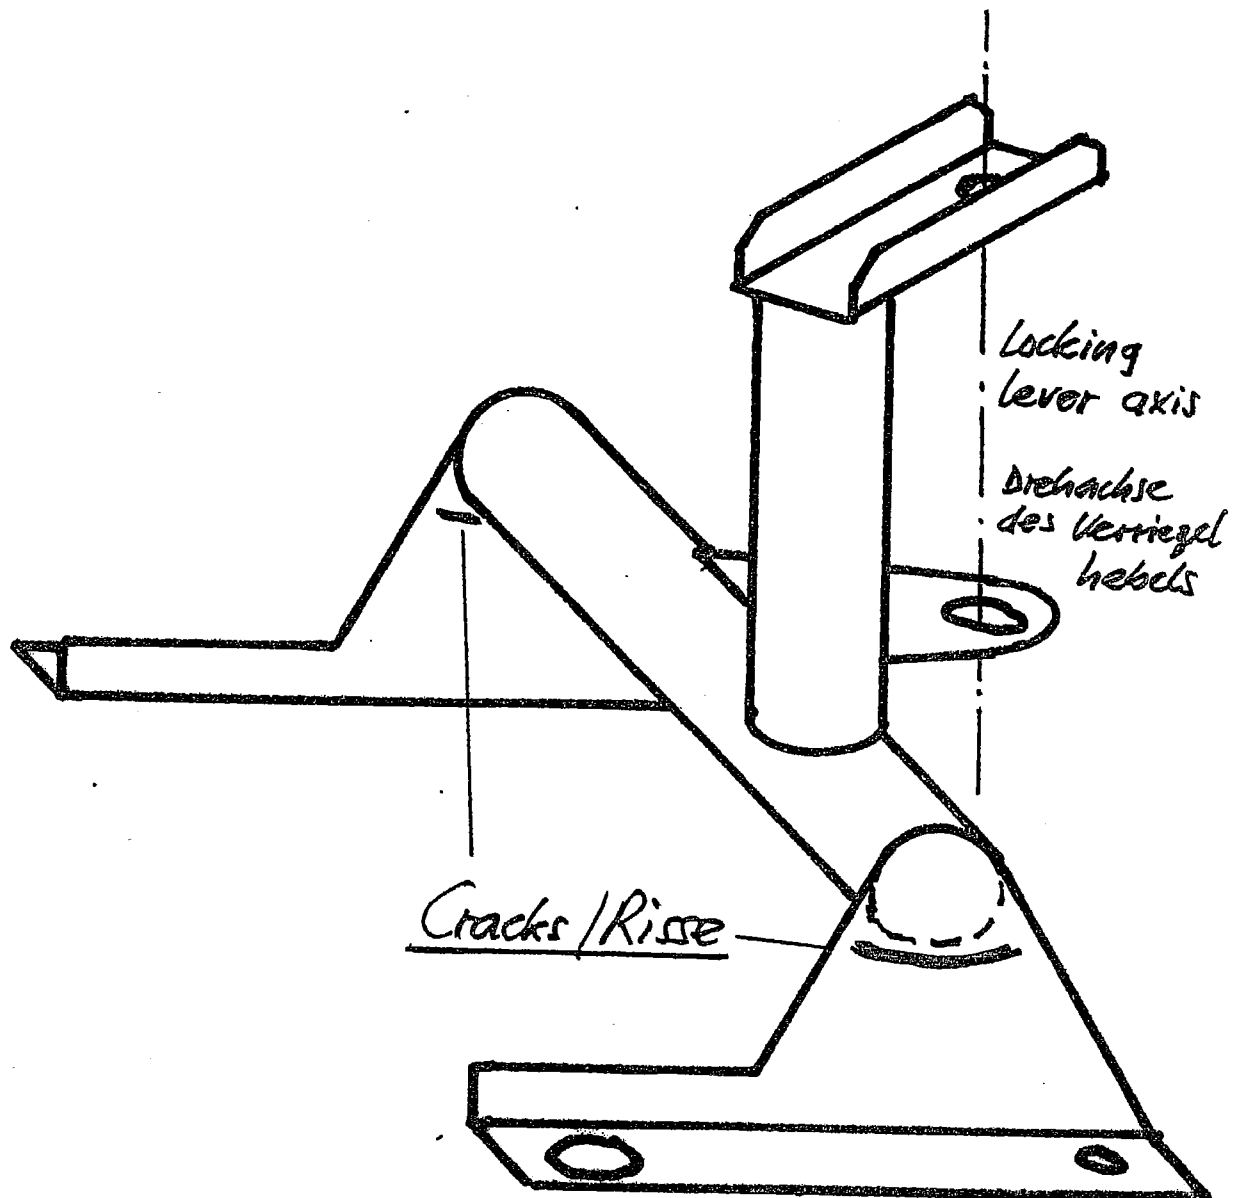
Due to possibly improper preflight checks, asymmetric adjustment of pushrods during exchange of L'Hotellier ball snap joints or uneven locking adjustments, the air brake locking bracket may be under long time asymmetric load, resulting in fatigue fracture at the lateral fixtures.

Lagerbock der Bremsklappenverriegelung rumpfseitig auf dem Fahrwerkskasten (Bereich auftretender Risse markiert)

Air brake locking bracket on landing gear box (Crack region marked)

- Material and Instructions:
1. With sailplane rigged, check air brake locking bracket on rear landing gear box for lateral movement during air brake locking.
  2. Check both fixing angles at this air brake locking bracket for lateral deformation (indication by cracks in paint or paint chipping off) and/or cracks in the welding region to the tube. (See sketch on page 2)
  3. Only with cracks or deformation existent, disassemble the bracket. Repair and modification required according to drawing 3R6-27b .
