LUFTFARTSDIREKTORATET
Avd. for Luftfartsinspeksjon
FORNÉBU-OSLO/Dep.
Tlf. : Oslo (02) 12 13 40
AFTN: ENFBYA
Tlgr. : CIVILAIR OSLO
Telex : 11032 Oslo

LUFTDYKTIGHETSPÅBUD
(LDP)

CESSNA
SAMMENDRAG
1946 - 1970

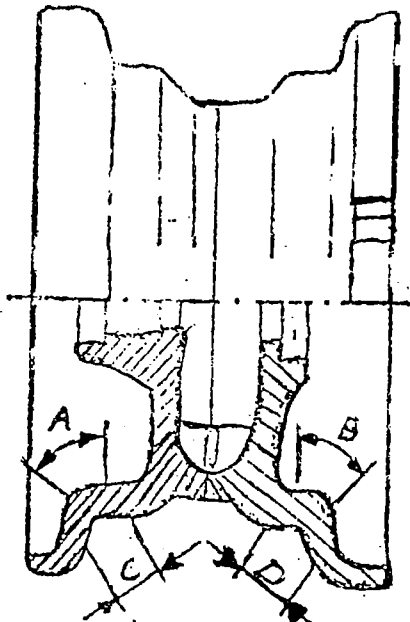
Da det er oppdaget tilfeller av sprekkdannelser i felgene for hovedhjulene skal følgende utføres:

2. Utføre samme kontroll som i pkt. 1, men på begge sider av felghalvdelene (dekkside og utside). Områdene A, B, C og D på figuren.

Dersom det oppdages sprekker skal felgen byttes ut før neste flyging. Videre skal funnet rapporteres til Luftfartsdirektoratet og følgende opplysninger skal gis:

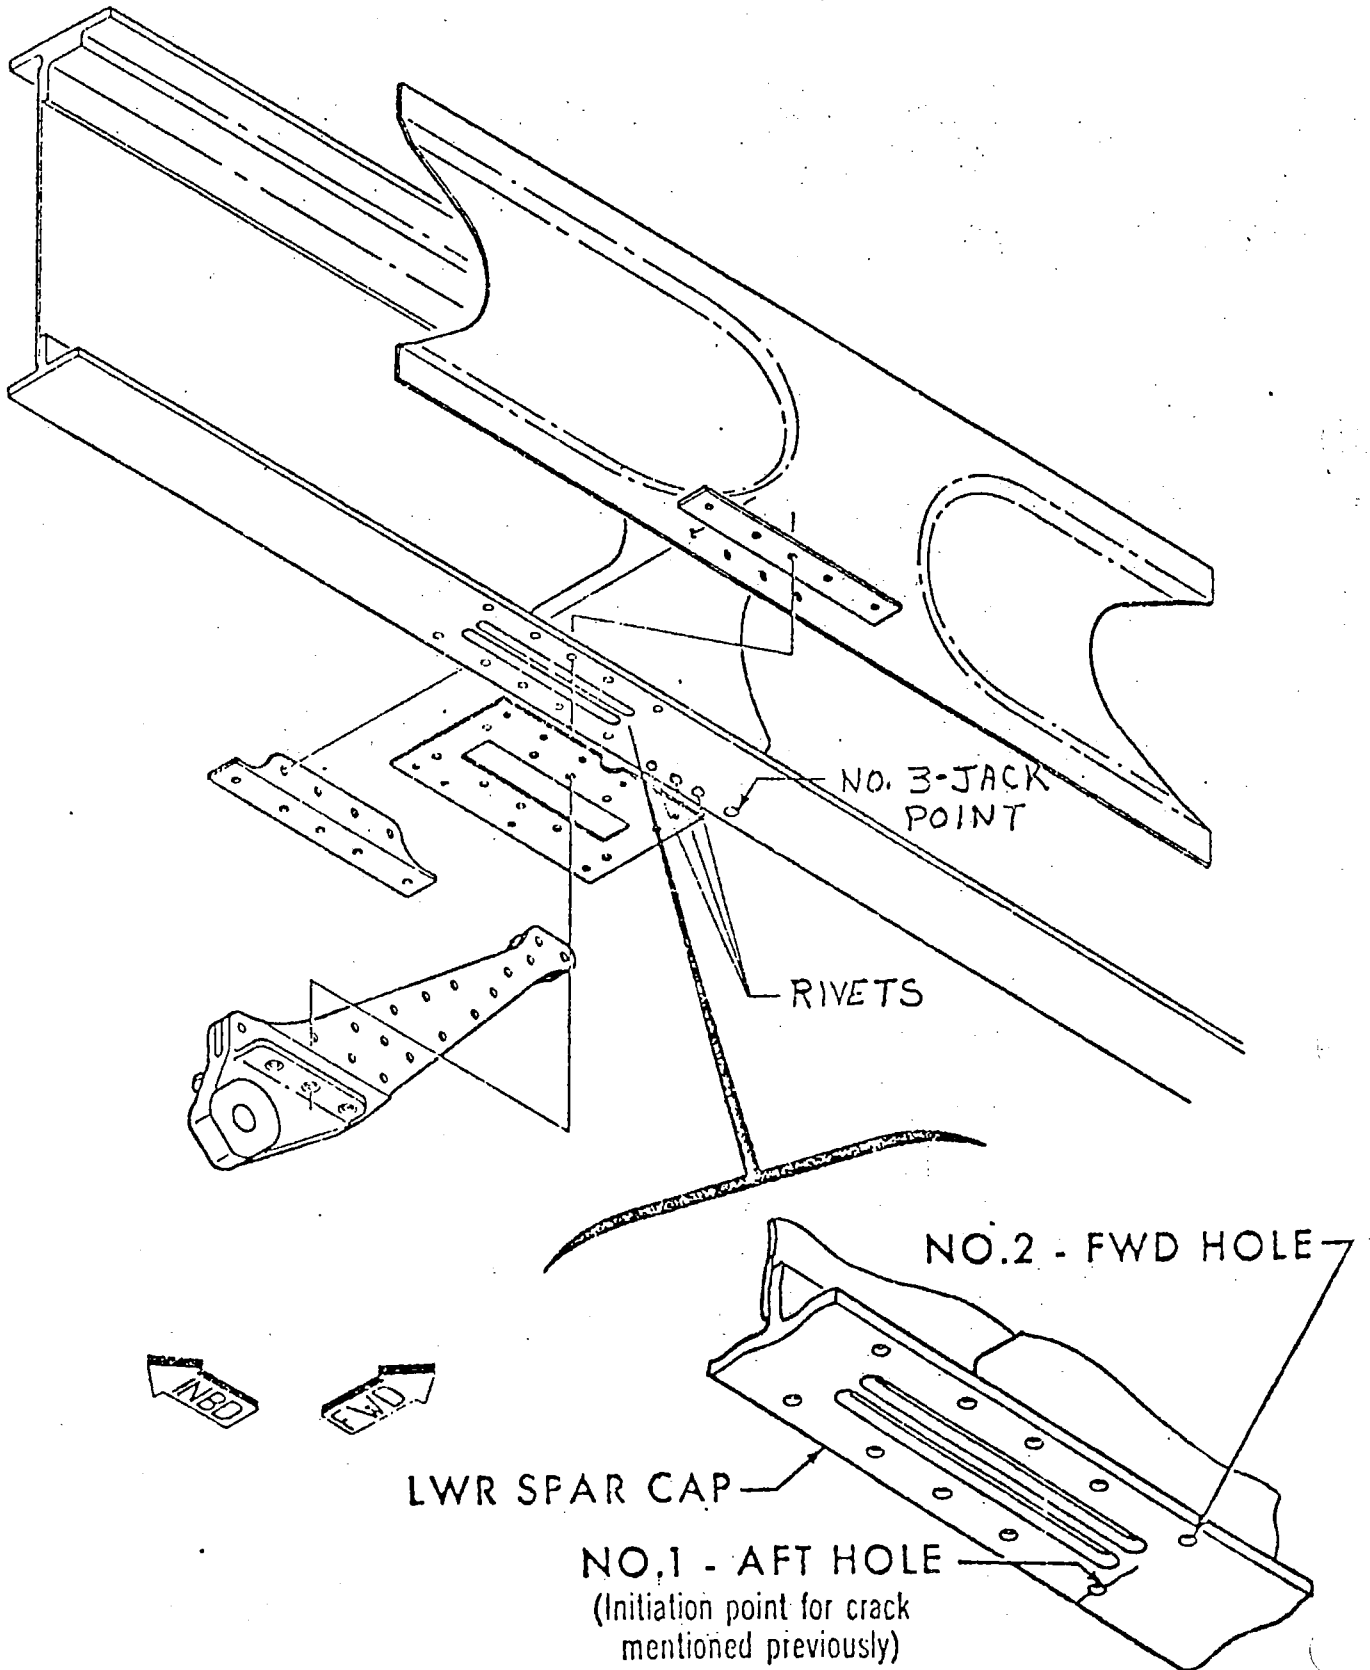
Fig. 3

FRONT WING SPAR-BOOM & STRUT ATTACHMENT AREA
L.H. Shown - R.H. Typical

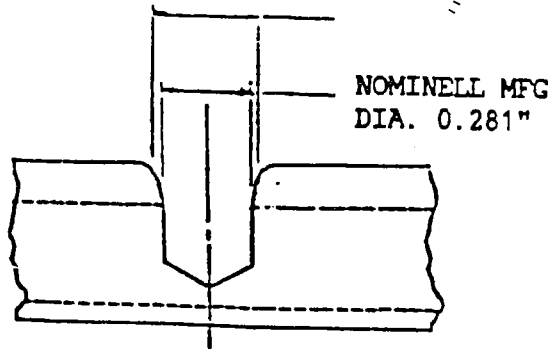
FIGUR 1a

TVERRSNITT AV GULVSKINNE
MED SLITASJE

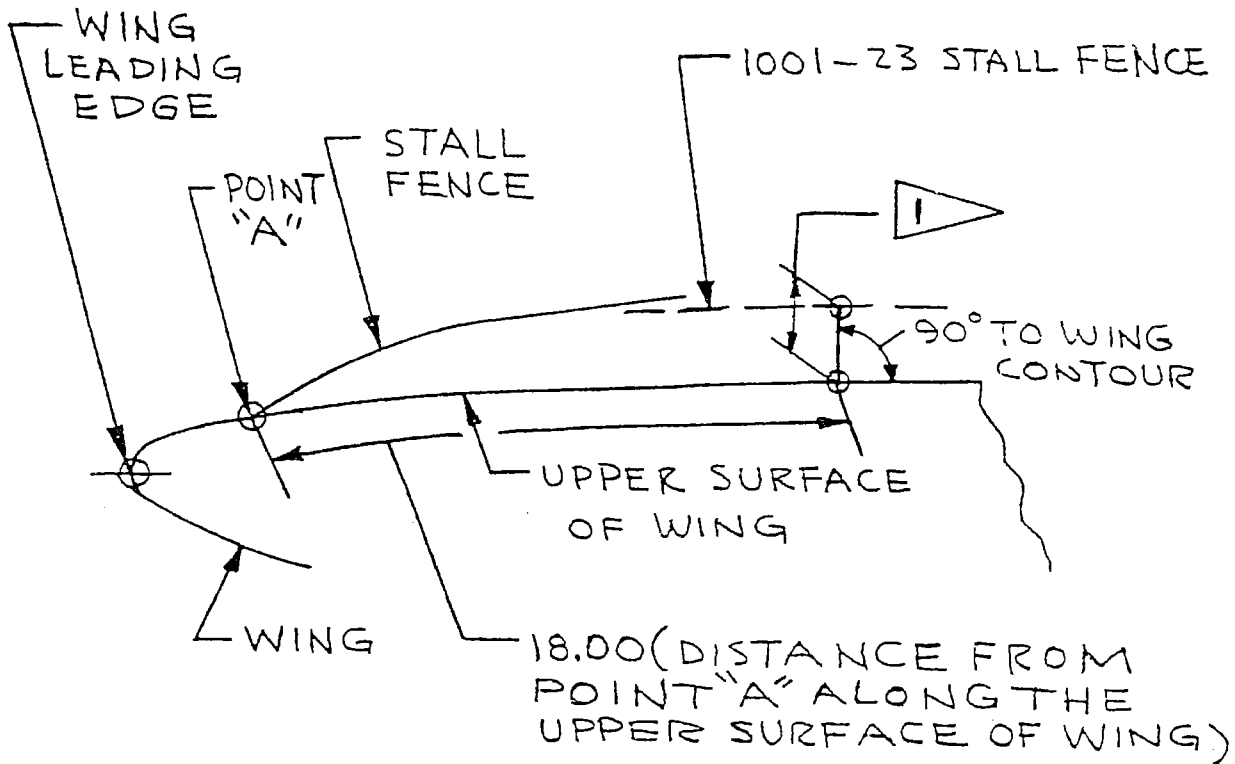
FIGURE 1
MID-AMERICA DWG No. 1001
(STC SA1371\$W)

1 IF STALL FENCE IS $1.16 \pm .12$ HIGH THAT IS CORRECT HEIGHT FOR CESSNA 150/152. IF GREATER THAN 1.28 HIGH REMOVE STALL FENCES AND INSTALL THE CORRECT ONE.

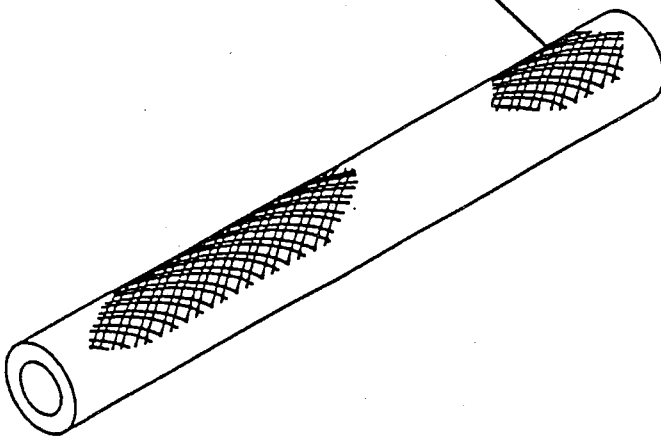
OLD STYLE S51-10 HOSE
WITH REINFORCEMENT
WRAPPED IN ONLY ONE
(DIAGONAL) DIRECTION THE
LENGTH OF THE HOSE
(REMOVE AND REPLACE WITH
REPLACEMENT STYLE HOSE)

REPLACEMENT STYLE S51-10
HOSE WITH A CRISS-CROSS
OR BRAIDED REINFORCEMENT
PATTERN

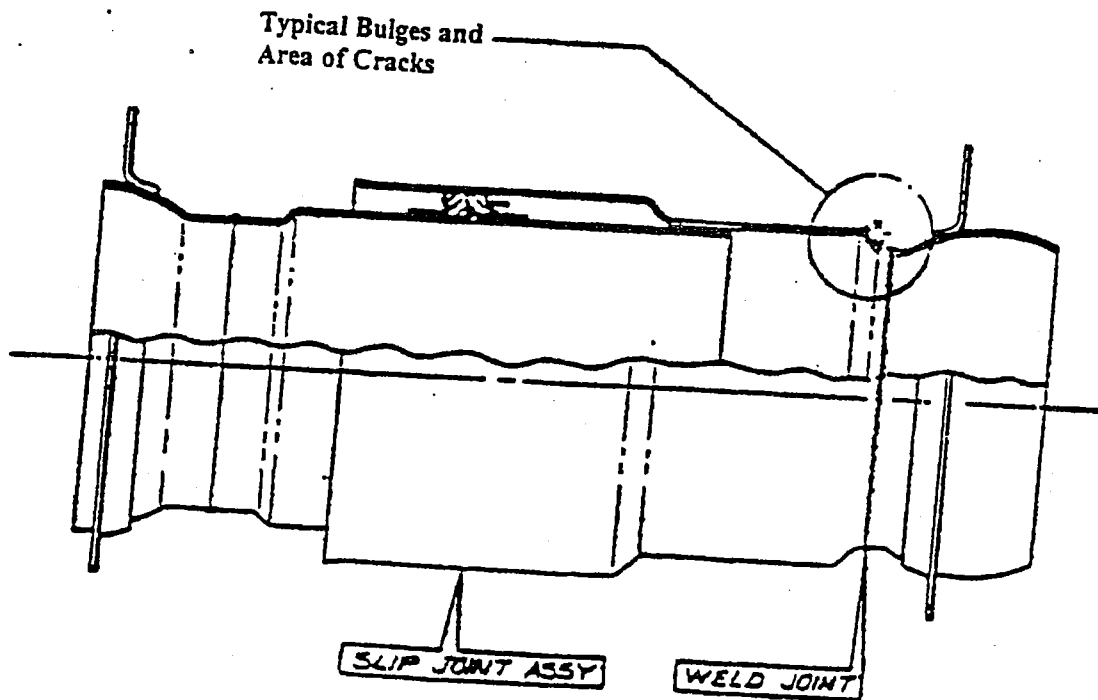
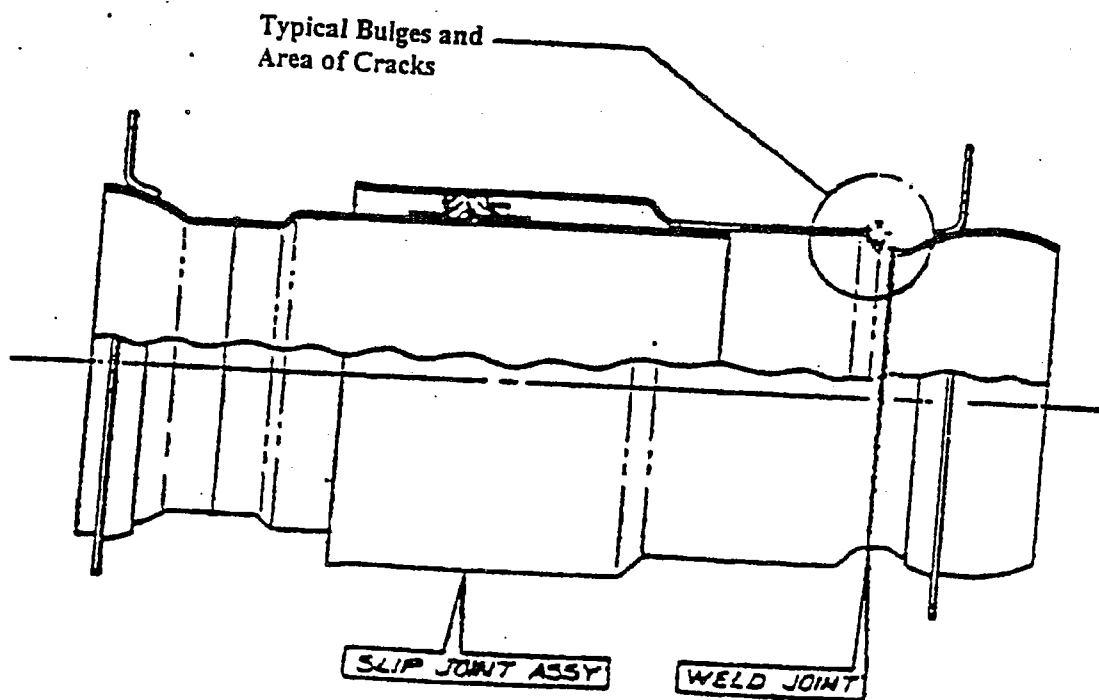
FIGURE 2 to the Appendix

(4) If installed, visually inspect the slip joint(s) for bulges beyond the normal manufacturing irregularities of .03 inches and/or cracks. If any bulges and/or cracks are present, replace the bulged or cracked slip joint(s). (Refer to the appropriate Cessna Aircraft Service Manual) (See Figure 2 of this Appendix).

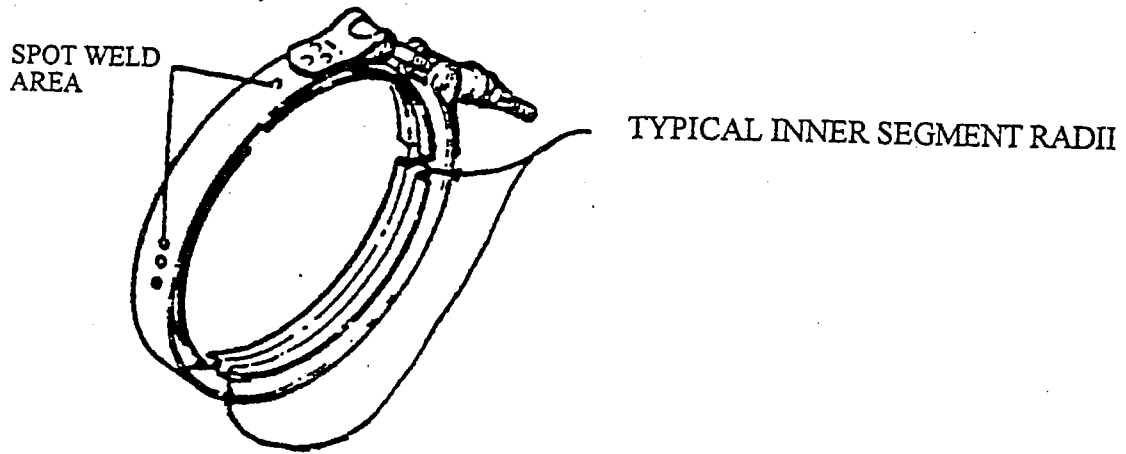
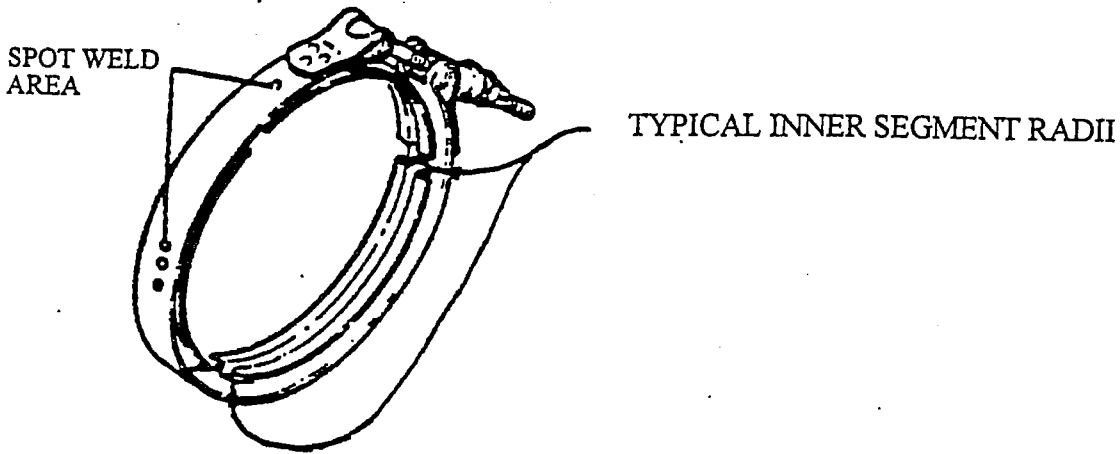
FIGURE 3 to the Appendix

(i) Visually inspect the outer band in the area of the spot weld for cracks (see Figure 3 of this Appendix). If cracks are found, replace the clamp(s) with new multi-segment "V" band clamp(s).

(ii) Visually inspect the corner radii of the clamp inner segments for cracks (see Figure 3 of this Appendix). This inspection requires careful use of artificial light and inspection mirrors.

than 0.062 inch. If deformation exceeds the 0.062- inch limit, replace the clamp(s) with new multi-segment clamp(s). (See Figure 3 of this Appendix). See Cessna maintenance manual(s) and revisions for correct installation procedures.

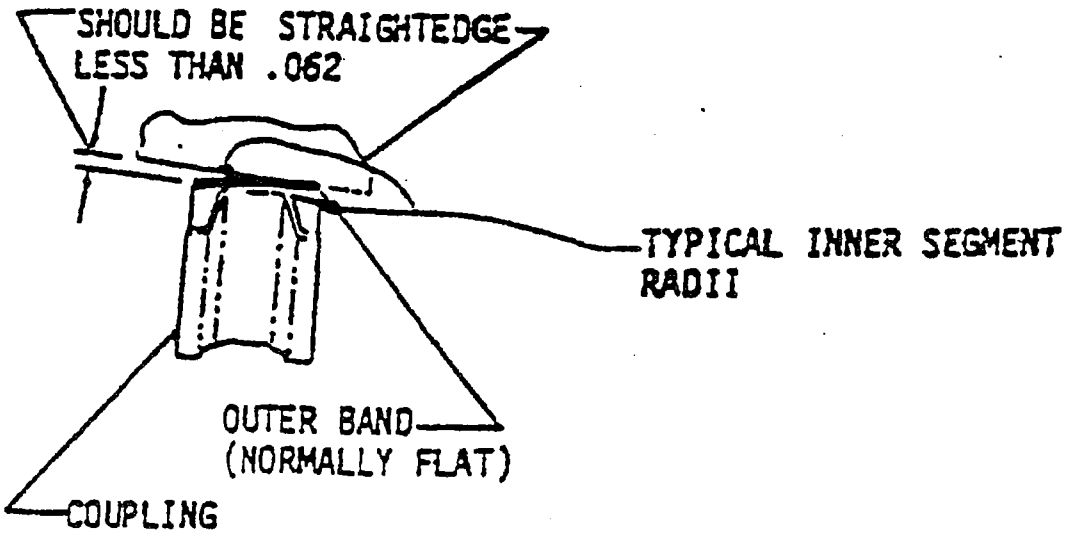
FIGURE 4 to the Appendix

(iii) Visually inspect the flatness of the outer band, especially within 2 inches of the spot welded tabs that retain the T-bolt fastener. This can be done by placing a straight edge across the flat part of the outer band as shown in Figure 4 of this Appendix, then check the gap between the straight edge and the outer band. This gap should be less

than 0.062 inch. If deformation exceeds the 0.062- inch limit, replace the clamp(s) with new multi-segment clamp(s). (See Figure 3 of this Appendix). See Cessna maintenance manual(s) and revisions for correct installation procedures.

Multi-Segment "V" Band Clamp Outer Band Flatness Check
