LUFTFARTSDIREKTORATET
Ave. for Luftfartsinspeksjon
FORNEBU-OSLO/Dep.
Tlf.: Oslo 1021 12 13 14
Aftl.: ENFRYA
Tegn.: CI/ALAK OSLO
Telex: 11022 Oslo

LUFTDYKTIGHETSPÅBUD

CONTINENTAL

1946 - 1970

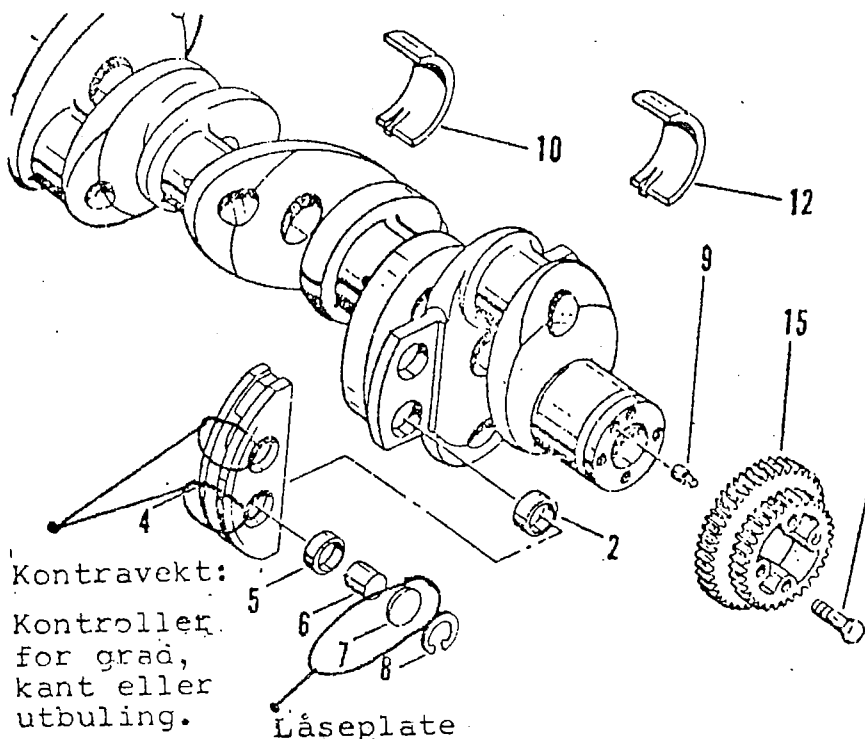
Fig. 1.

1. På grunn av inntrufne tilfeller av at låseplaten for veivakselens kontravekt-pin's P/N 628979 slites gjennom toppen av veivakselens kontravekt har Luftfartsverket bestemt at ny type låseplate med P/N 633976 monteres ved første overhaling av motoren, eller hvis sylinder nr. 1 eller sylinder nr. 2 er avmontert av andre grunner før den tid.
2. Videre skal følgende inspeksjon utføres:
 - a. Demonter blindplugg for timing plassert ved siden av sylinder nr. 2.
 - b. Roter veivakselen sakte rundt og gjennom timing-hullet, kontroller i området rundt toppen og på begge sider av veivakselens kontravekt.
 - c. Hvis grad eller antydning til kant observeres (se fig. 1) er dette en indikasjon på at låseplaten har begynt å slite seg gjennom kontravekten. Ved et slikt tilfelle, demonter sylinder nr. 1 eller sylinder nr. 2 og skift kontravekt og låseplate.

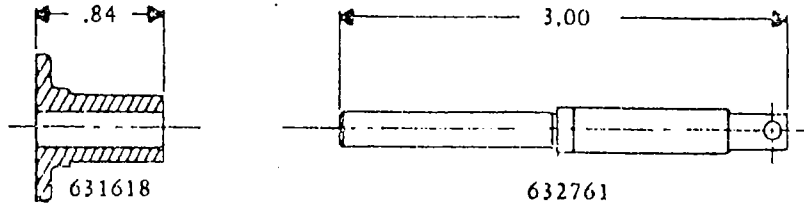
FIGURE 1

For å unngå mulig tap av oljetrykksindikasjon skal huset for oljetrykksventilen kontrolleres for å se om det er påmalt en gul flekk. Dersom malingsflekken finnes, gjelder ikke denne LDP. I motsatt fall skal trykkventilen tas av og skrue og stempel kontrolleres ved å sammenligne dimmensionene i figur 1, 2 og 3 med henholdsvis skrue og stempel.

ORIGINAL DESIGN

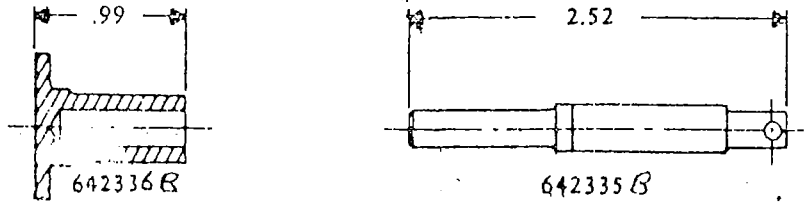
FIGURE 3

Dersom skrue og stempel stemmer overens med dimmensioner i figur 2, "Intermediate Design", må delene skiftes ut med deler som stemmer overens med deler i figur 2, "Current Design". Disse fås i TMC Kit 642335A1. Skrue og stempel som stemmer overens med figur 1, "Original Design" kan fortsatt brukes. Hvor skrue og stempel stemmer overens med figur 1 og 3, skal ventilhuset merkes med en gul malingsflekk.

CURRENT DESIGN
