LUFTFARTSVERKET
Novedadministrasjonen
Avd. for luftfartsinspeksjon
Postboks 18, 1330 Oslo lufthavn
Telefon: Oslo (02) 59 33 40
AFTN : ENFBYE
Tlgr. : CIVILAIR OSLO
Telex : 77011 Idal n

LUFTDYKTIGHETSPÅBUD (LDP)

ROBINSON - 1

1056/90 MODIFIKASJON AV LUFTFILTERHUS

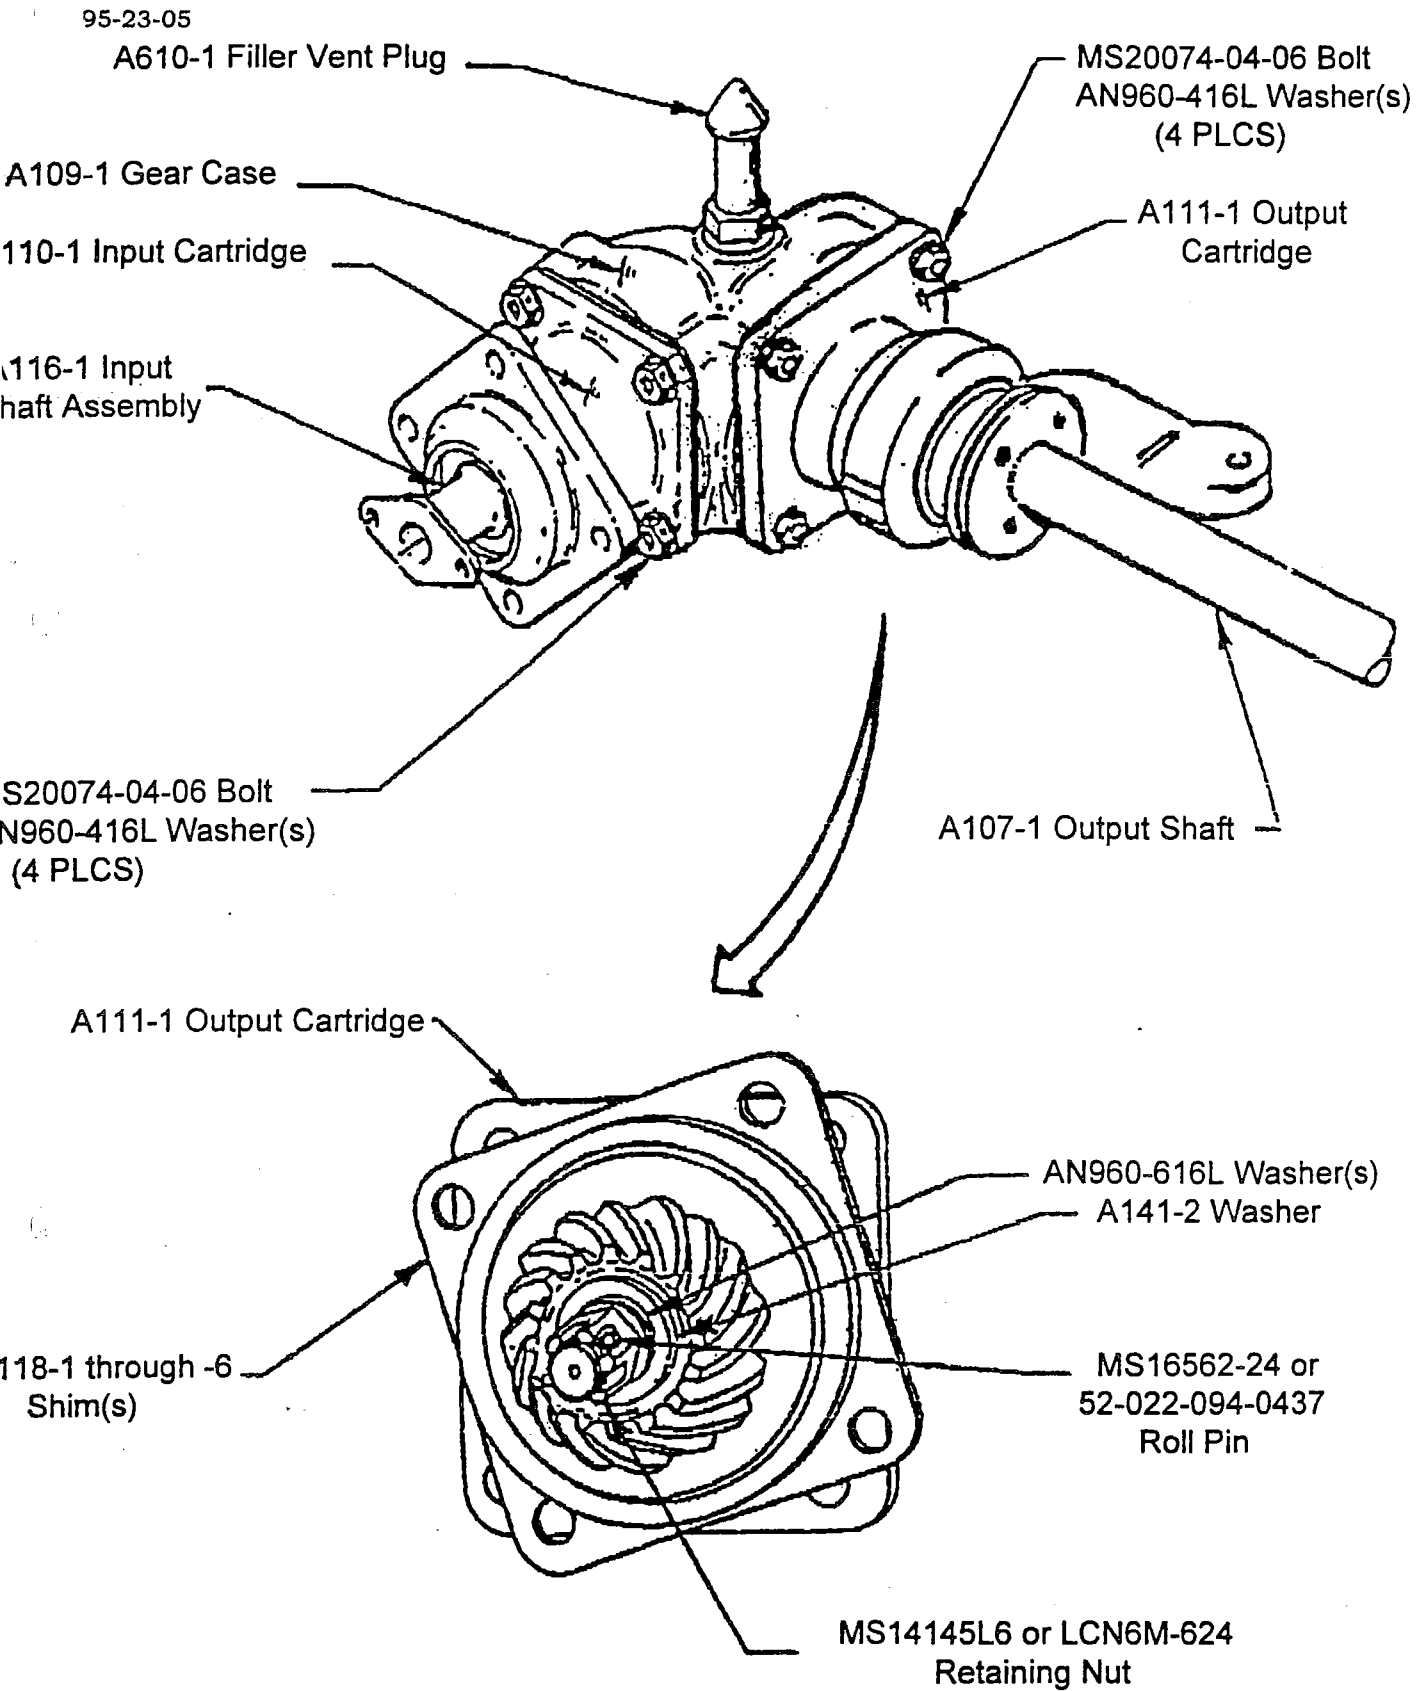
Figure 1

Note: The safety wire has been removed for clarity

(iv) Visually inspect for the presence of the output shaft key, P/N A114-2, between the pinion gear, P/N A545-1, and the output shaft (see figure 2).

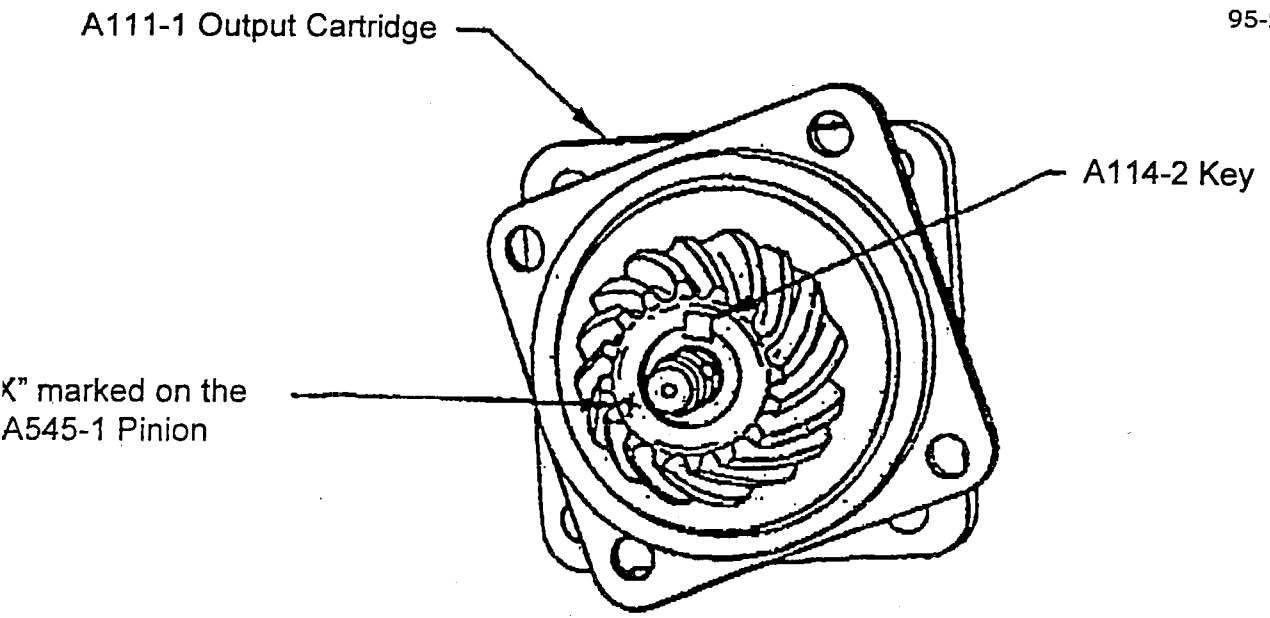
Figure 2

Note: The A114-1 Key for the A110-1 Input Cartridge is located similar to the A111-1 Output Cartridge depicted above

(iv) Visually inspect for the presence of the input shaft key, P/N A114-1, between the gear, P/N A545-2, and the input shaft (see Note on figure 2).

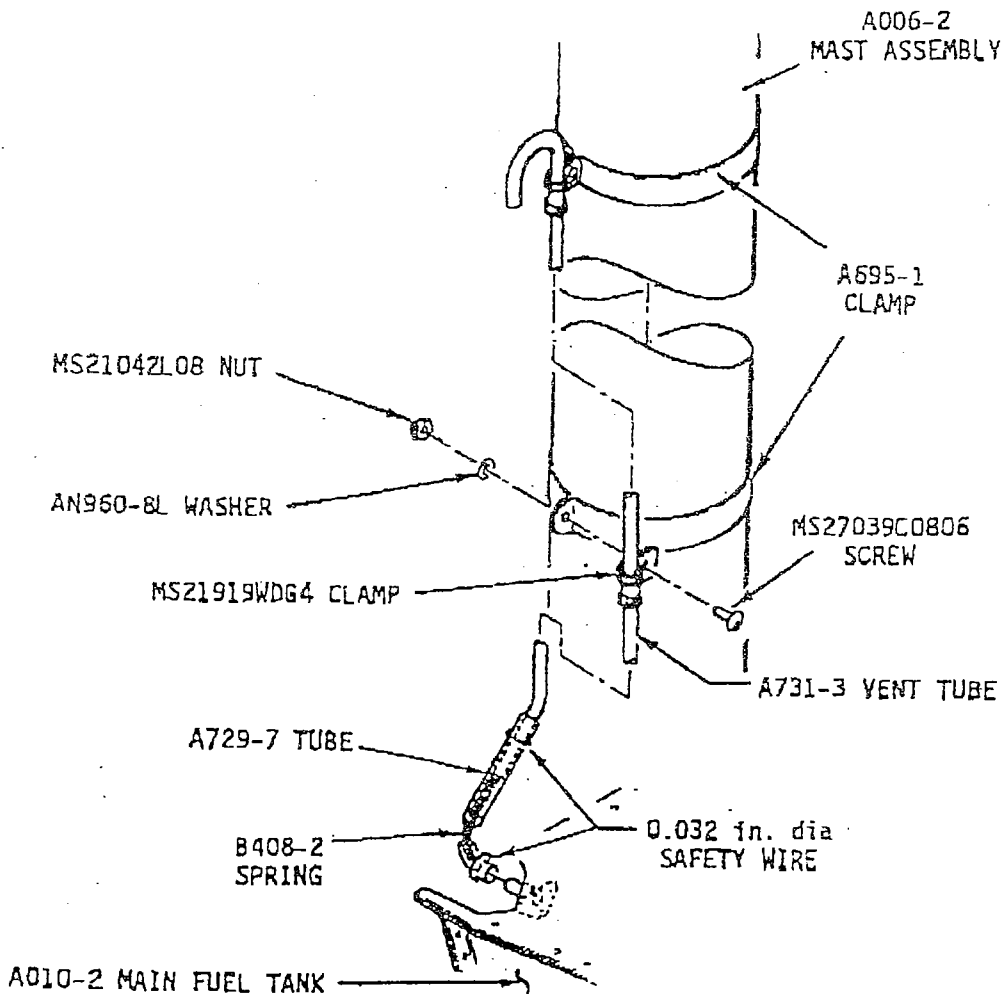
FIGURE 1
AD 98-21-09

HELICOPTER WITHOUT AUXILIARY FUEL TANK

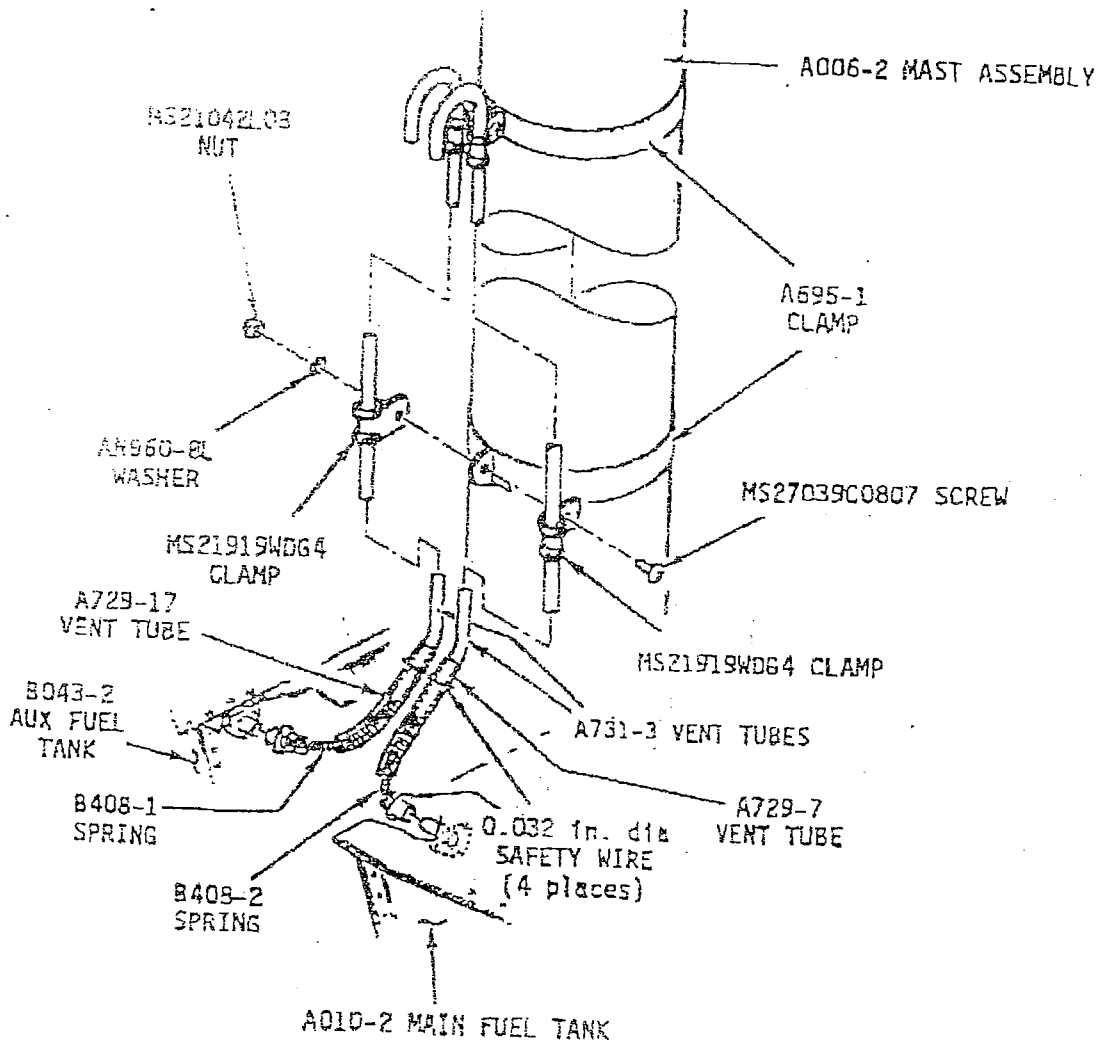
FIGURE 2
AD 98-21-09

HELICOPTER WITH AUXILIARY FUEL TANK

(2) For helicopters with an auxiliary fuel tank installed, remove the existing main fuel tank vent tube, P/N A731-1, and auxiliary fuel tank vent tube, P/N A731-2, and install airworthy vent tubes, P/N A731-3, with flexible tube, P/N A729-7, for main tank and flexible tube, P/N A729-17, for auxiliary tank using MS27039C0807 screw and AN960-8L washer (alternate P/N NAS1149FN816P) at lower clamp, P/N A695-1 (see Figure 2).
